Technical Service Bulletin

Squeak or rattle noise in front door area or front sunroof area

50 07 01 Feb. 6, 2007, 2014189/1

Model(s)	Year	VIN Range	Vehicle-Specific Equipment
A6	2007	All	Not Applicable

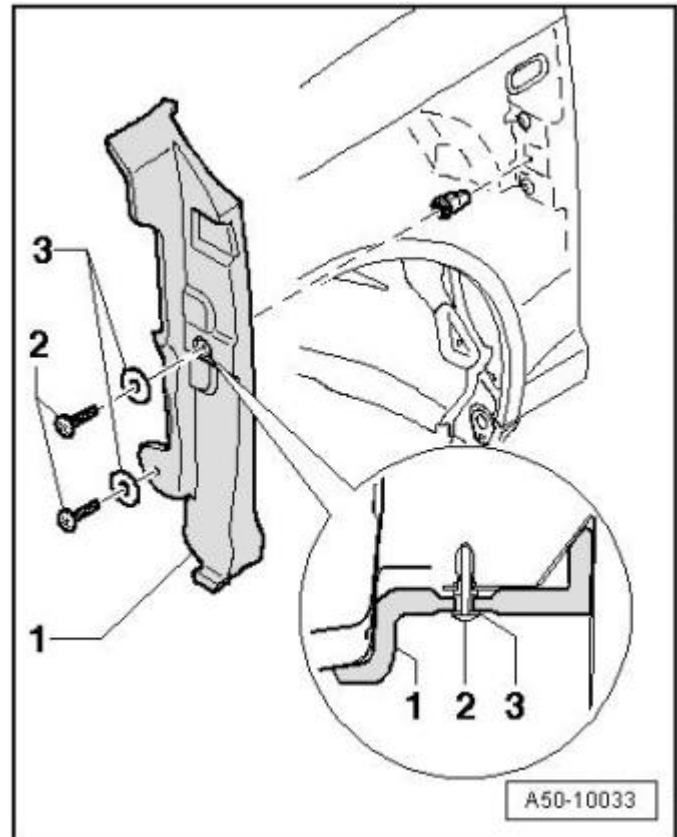
Improperly fitted foam insulation (end plate) in front fenders.

Figure 1: The front fender. Refer to *ELSA repair manual* for front fender assemble overview.

1. Remove front wheel.
2. Remove wheel housing liner.
3. When working on the left side of the vehicle, remove the windshield washer fluid container.
4. Unscrew bolts (Figure 1, Point 2) from expanding clip (Figure 1, Point 3).
5. Remove end plate.

Tip: Tightening torque for bolts (Figure 1, Point 2) is 1.5 Nm.

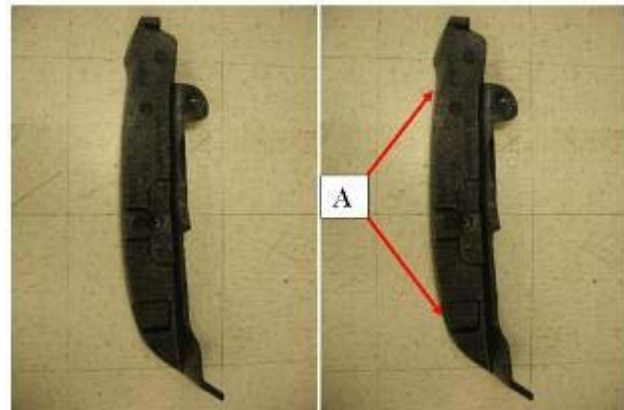
Figure 2: The end plate. Cloth tape should be installed on the entire surface of side A.

6. Install cloth tape on the entire surface on side A shown in Figure 2.
7. Reinstall the end plate into the fender in reverse order.
8. Test drive vehicle to verify proper repair.
