Technical Service Bulletin

Luggage Cover is Noisy

68 06 04 Oct. 31, 2006, 2012996/1

Model(s)	Year	VIN Range	Vehicle-Specific Equipment
A6 Avant	2006	000001 – 177000

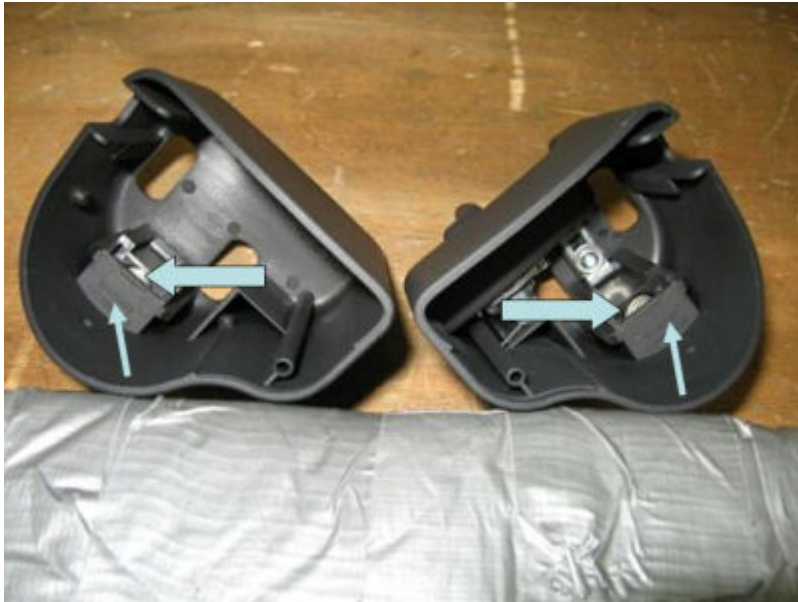
The luggage cover creaks when driving on poor roads.

At times, the springs under the caps may make noise.

Remove the caps. Grease the springs and the contact surfaces at the points marked by the arrows in the illustration below.
