Technical Service Bulletin

Net partition noisy

68 06 05 Nov. 16, 2006, 2013328/1

Model(s)	Year	VIN Range	Vehicle-Specific Equipment
A6 Avant	2006	All	Not Applicable
A6 Avant	2007	000001 – 014160

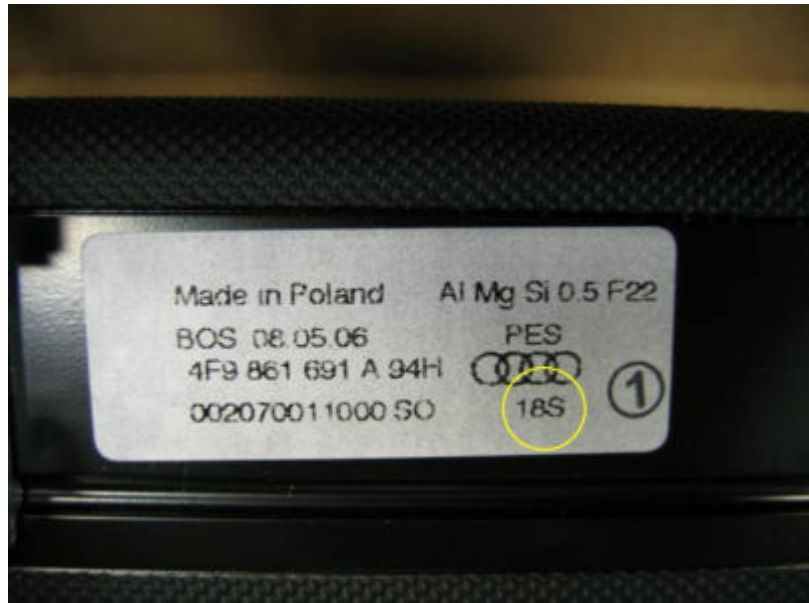
Figure 1. You will find a white sticker similar to this on the net partition. In this figure, the parts version is circled in yellow.

Replace the net partition parts version **22S** or higher. The parts version is written on the white sticker on the net partition.

Tip: The Parts Department only supplies parts with version **22S** or higher.
