Subject: Trim Panels, Rattle

Number: 05-02

Model(s): A6

Date: Jun. 9, 2005

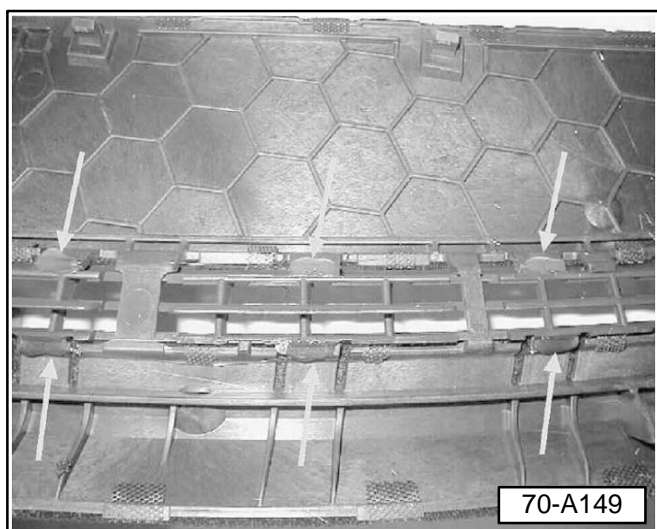
Below VIN: 4F_5N003525:

Defrost grill trim has loose holding clips.

- ◀ - Secure all holding clips to defrost grill trim with hot glue (see illustration).
- Verify position of Glove box door.

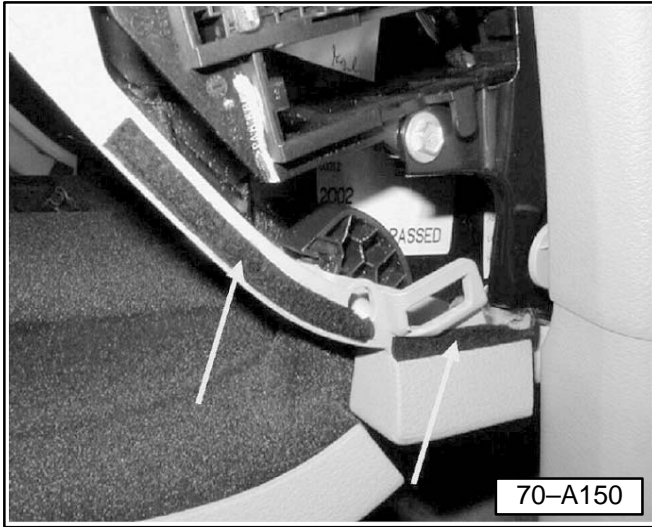
Below VIN: 4F_5N060000:

Left and right side cover trim creaking against dash panel.

- ◀ – Install two felt strips as shown (see illustration).
- Apply Teflon spray to holding clips.

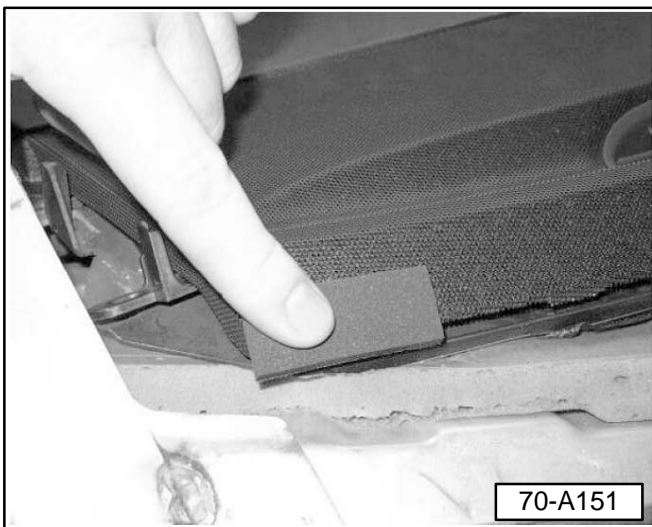
Below VIN: 4F_5N062705:

Gap between defrost trim grill and windshield is too small.

- ◀ – Install foam block Part No: 443 201 365B (size 20mm x 20mm x 6mm) to right side of defrost trim grill as shown.
