Technical Service Bulletin

Trim for Tailgate Noisy

70 06 03 Oct. 20, 2006, 2012960/1

Model(s)	Year	VIN Range	Vehicle-Specific Equipment
A6	2005 – 2006	All	Not Applicable

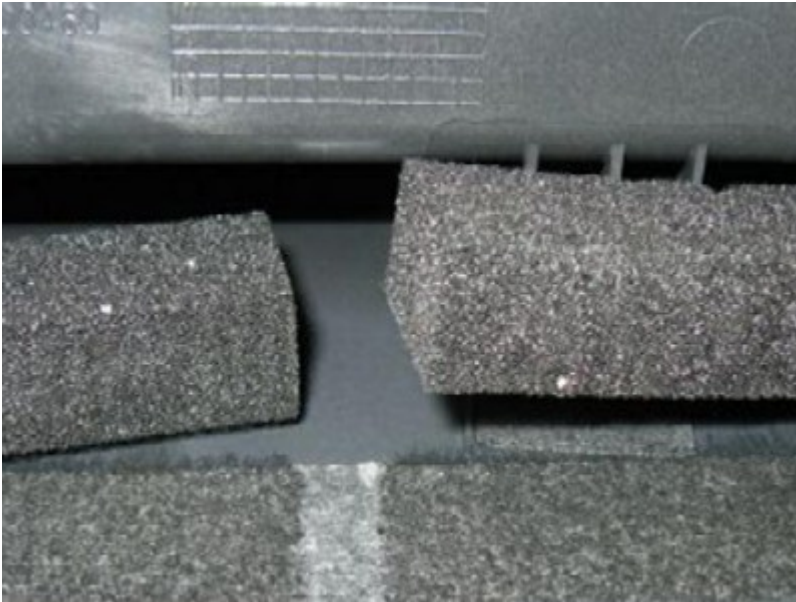
Illustration 1

- 1.The foam strip under the trim has come off.
- 2.There is not enough space between the trim and the body.

- 1.Remove the tailgate trim and check to see if the foam strip has come off. (See Illustrations 1 and 2.) Remove the old foam, including the adhesive tape, and use new adhesive tape (Part No. 8E0 831 575 A) to reattach the foam.
- 2.Attach felt to all contact surfaces, such as support turrets and edge areas of the trim. (See Illustrations 3 and 4.)
- 3.The plastic turrets must be glued with body bonder to ensure a firm fit, as shown by the yellow circles in Illustration 4.
