Technical Service Bulletin

Cursor is jumping in radio memory list (possible Navigation DVD upgrade)

91 07 06 2014281/1, Feb. 20, 2007

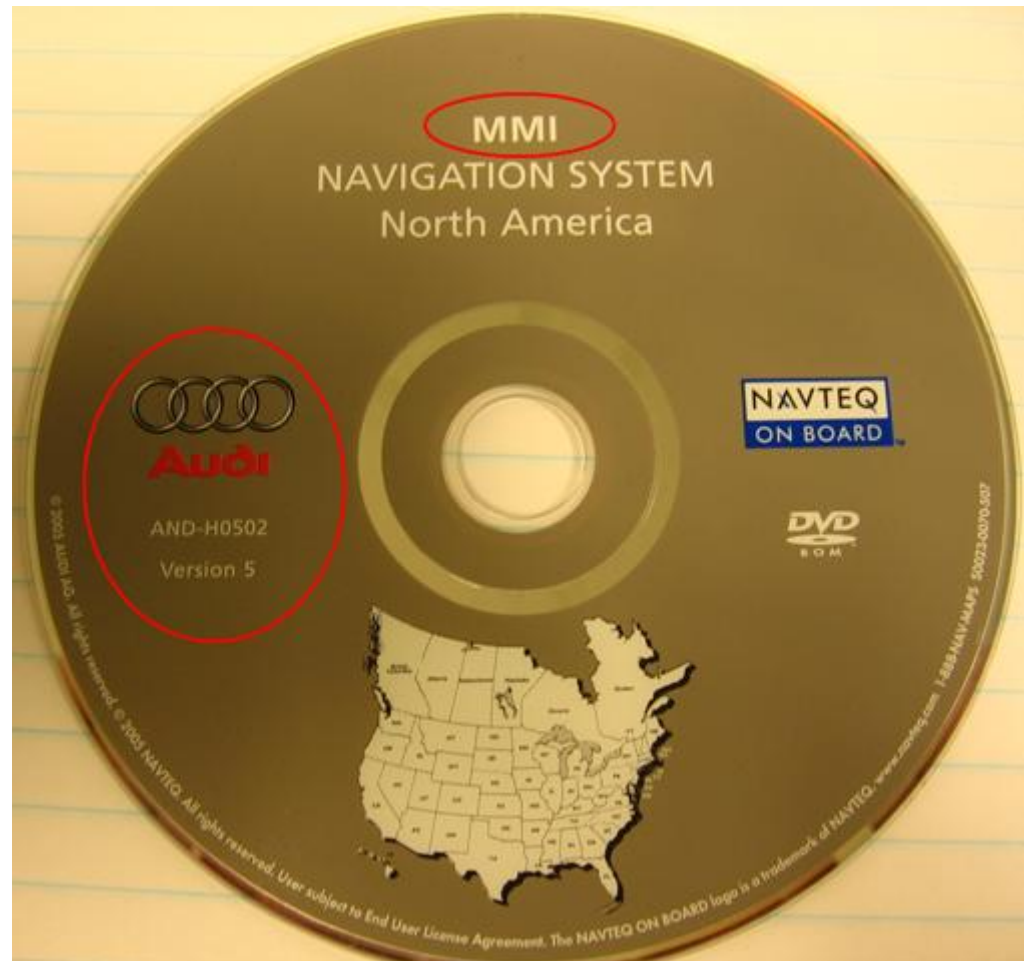
Figure 1. An MMI Navigation System Version 5 DVD.

If the Navigation DVD Version is already 5 or higher (Figure 1), proceed to the MMI component update without further action.

3. Verify which Navigation DVD Version is currently installed. If the version is 4 or lower, obtain a Version 5 Navigation DVD through the Navteq Hotline. Replace the DVD and run the **Navigation Update** in the MMI **Navigation** menu.

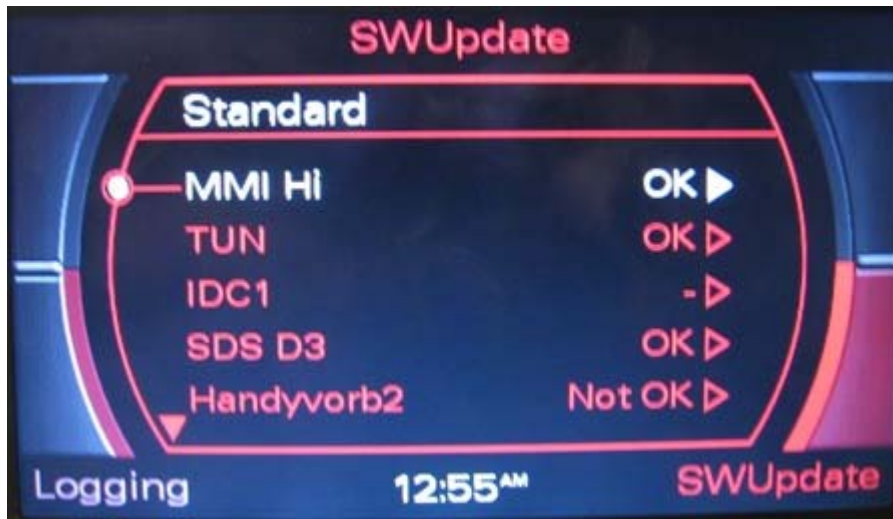
Tip: The displayed status **Not OK** and - is update-related and not a fault. Please ignore and proceed.

13. After initialization of the updated components, the following screen (or a similar one) appears.
