Technical Service Bulletin

MMI Surround setting lost

91 07 08 2013108/2, Feb. 20, 2007. Supersedes Technical Service Bulletin Group 91 number 06-25 dated Nov. 1, 2006 due to release of new update CD.

Model(s)	Year	VIN Range	Vehicle-Specific Equipment
A6	2006	All	BOSE Sound System
A8	2006	All

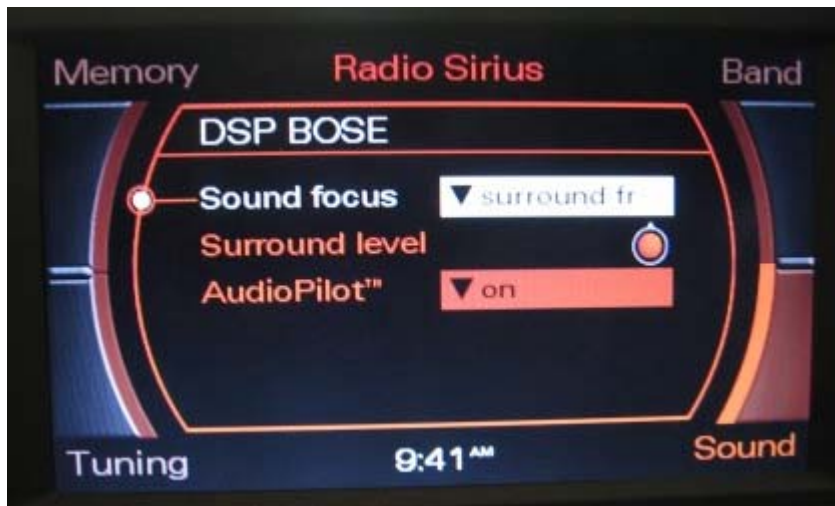
The customer complaint is that the DSP BOSE sound setting does not remain on **surround fr** or **surround rear**.

An MMI System - Update must be performed.

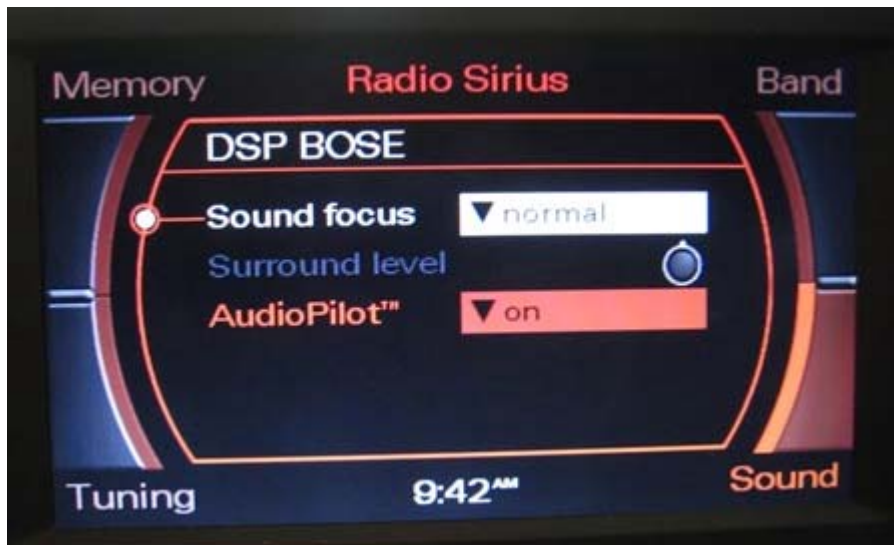
Instead, **normal** is displayed, and the corresponding sound focus is audible.

The unwanted behavior occurs only after a sleep cycle of the MMI system. The sound setting does not change by itself during a driving cycle.
