Technical Service Bulletin

Only one satellite radio station is displayed and playing with activated Tuner

91 07 11 2014223/1, Feb. 20, 2007

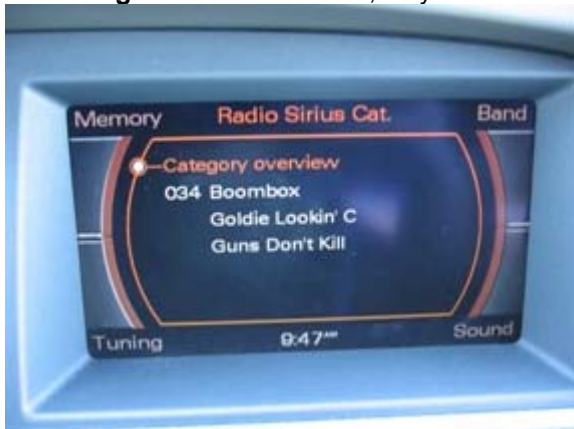
Only one satellite station is available in the station list. Other stations can be selected consecutively with **Scan** in the **Tuning** submenu. However, only one station is always listed and audible.

Due to a communication issue between the Sirius Satellite Tuner and Front Information Display Control Module J523, the complete station list is not transferred.

Do not replace the satellite tuner. A software update is required.

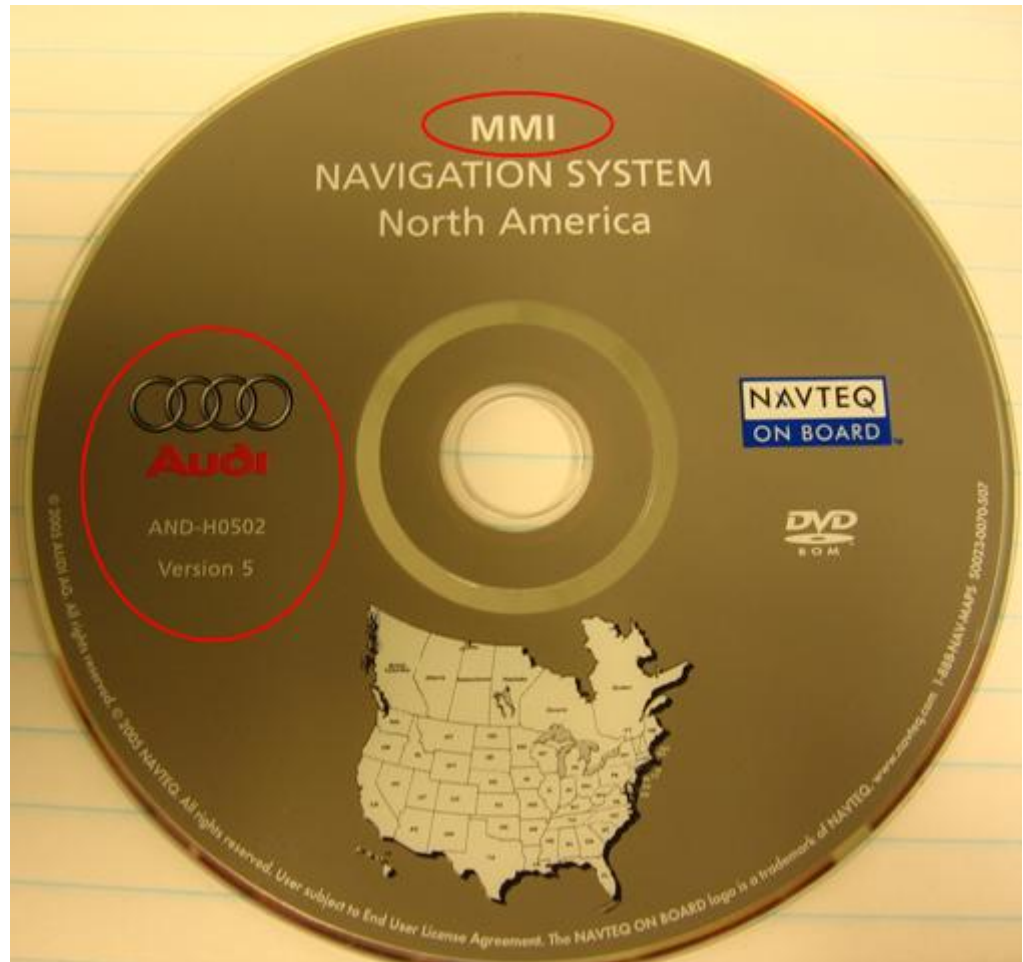
Figure 1. An MMI Navigation System Version 5 DVD.

If the Navigation DVD Version is already 5 or higher (Figure 1), proceed to the MMI component update without further action.
