# Technical Service Bulletin

## MMI Surround setting lost

91 07 22 May 21, 2007 2015136/1

Model(s)	Year	VIN Range	Vehicle-Specific Equipment
A6	2005	All	BOSE System and Zug 317 installed
A8	2004 – 2005	All

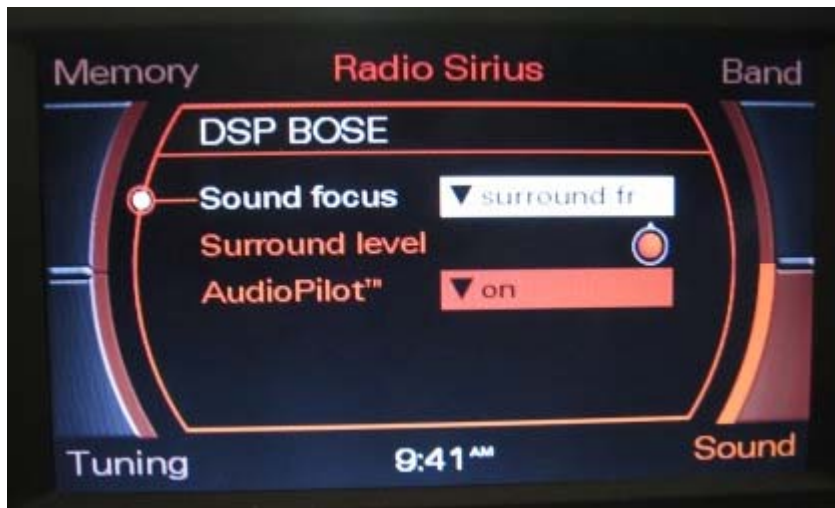
The customer complaint is that the DSP BOSE sound setting does not remain on **surround fr** or **surround rear**.

The unwanted behavior occurs only after a sleep cycle of the MMI system. The sound setting does not change by itself during a driving cycle.

1. Verify that the software level in **07 - Display control unit** is 1070.
  - **If this is not the case**, contact the Audi Technical Assistance Center for further instruction.

- **If this is the case**, an MMI System - Update must be performed, and Navigation DVD Version 5 must be installed due to compatibility issues.

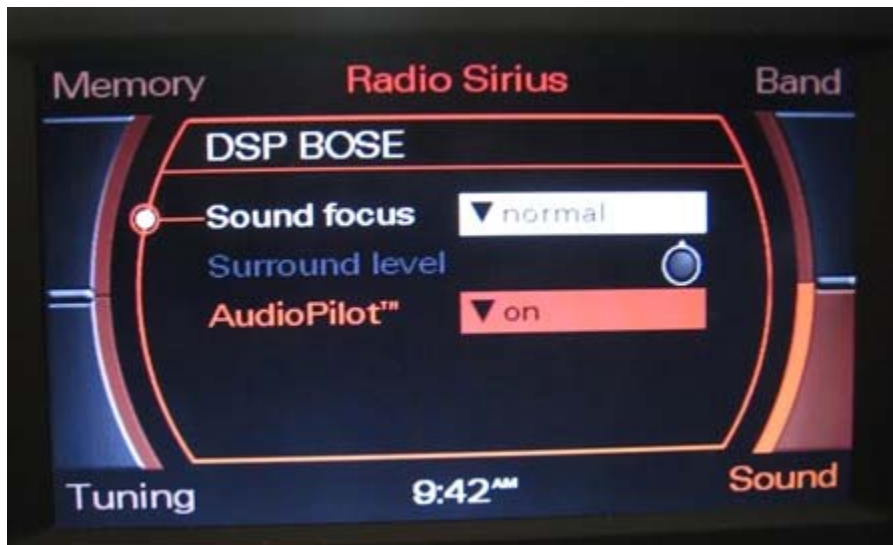
Instead, **normal** is displayed, and the corresponding sound focus is audible.
