Technical Service Bulletin

Hose to rear washer jet leaking; Bose soundsystem, MMI, or navigation without function

92 06 01 Oct. 24, 2006, 2013209/1

Model(s)	Year	VIN Range	Vehicle-Specific Equipment
A6 Avant	2005	All	Not Applicable
A6 Avant	2006	4F_6N000001 – 4F_6N060000

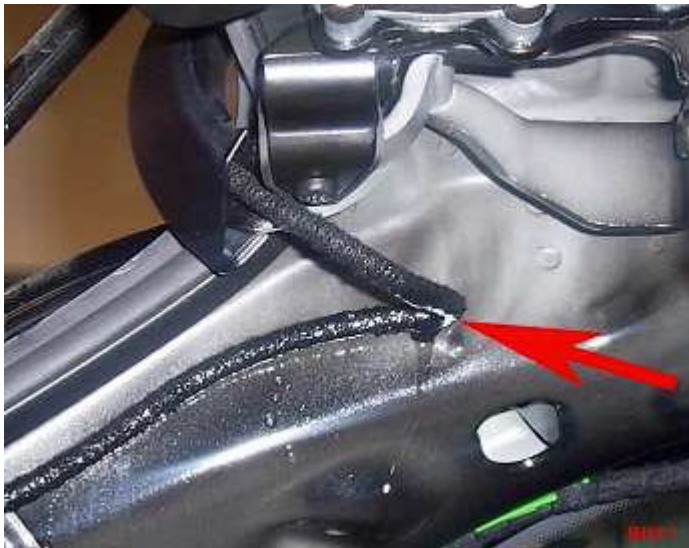
The washer fluid hose to the rear washer jet breaks near the last mounting on the D-pillar due to opening and closing of the tail gate. (See Illustration 1.)

As a result, the washer fluid is entering the vehicle in the left rear corner causing water ingress to the electrical connections of one or more electrical components.
