Technical Service Bulletin

RVU - A6 Avant rear washer hose (IT)

92 07 01 March 2, 2007, 2013391/3. Supersedes Technical Service Bulletin Group 92 number 06-03 dated Nov. 27, 2006 due to addition of Saga warranty information.

Model(s)	Year	VIN Range	Vehicle-Specific Equipment
A6 Avant	2006	All	Not Applicable

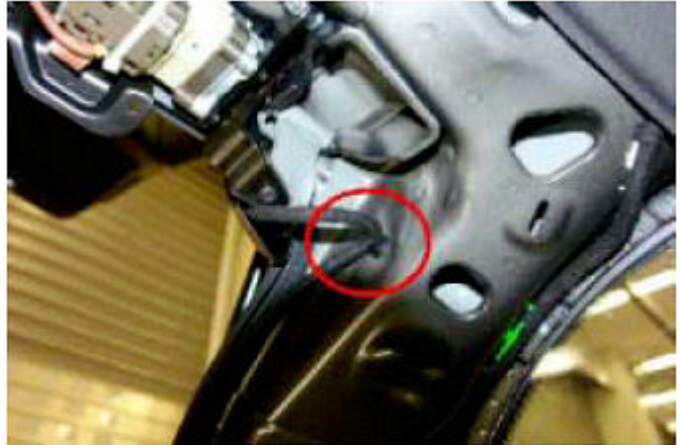
On Audi A6 Avant vehicles built within a specific period, it is possible that the hose for the rear window washer may become damaged by constant bending and start leaking.

Figure 5. A reinforcing hose must be installed in the area marked in red to protect the rear window washer hose.

A reinforcing hose must be installed on the affected vehicles.

A reinforcing hose has to be installed in the area marked to protect the rear window washer hose.

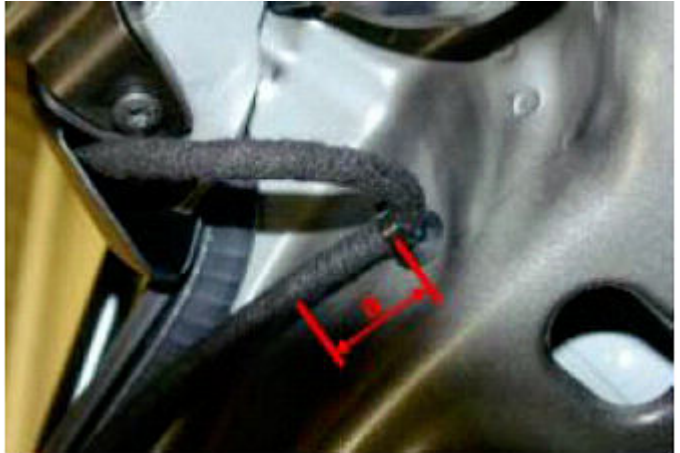
Figure 6. Measure a distance of 15 mm (A) from the cable tie.

- Measure a distance of 15 mm (Figure 6, A) from the cable tie, and mark this point with a suitable pen.

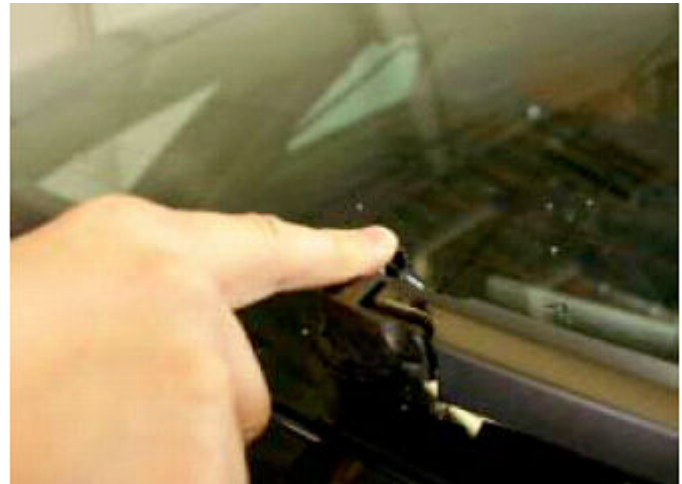
- Operate the rear window washer for approximately five seconds while a second mechanic holds a finger over the washer nozzle to keep it closed.
- Then check the hose for leaks in the vicinity of the cable tie (visual inspection).

Figure 9. Have a second mechanic hold a finger over the washer nozzle to keep it closed. Operate the rear window washer for approximately five seconds.

If the rear window washer hose is leaking, it must be repaired as described in TSB 2013209/1 *Hose to rear washer jet leaking*.

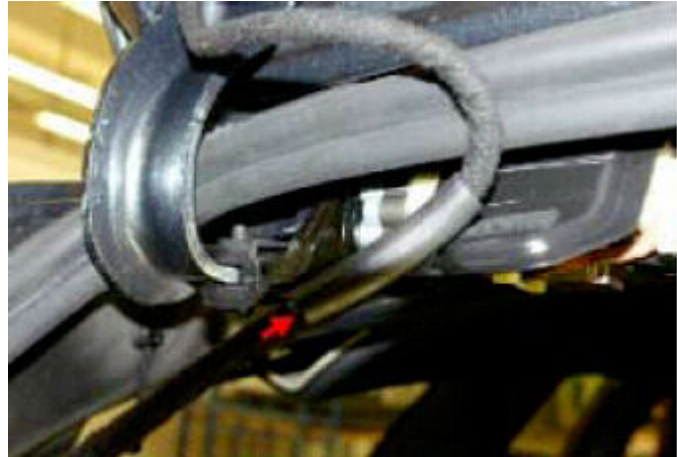
Figure 10. The lower end of the reinforcing hose starts at the point marked here with an arrow.

- Install the reinforcing hose (which is slit open for this purpose). The lower end of the hose starts at the marking (Figure 10).
- Hold the hose in its final position and check the position of the slit. Turn the reinforcing hose so that the slit faces the body of the vehicle.
- Wrap fabric-backed adhesive tape tightly around the reinforcing hose.

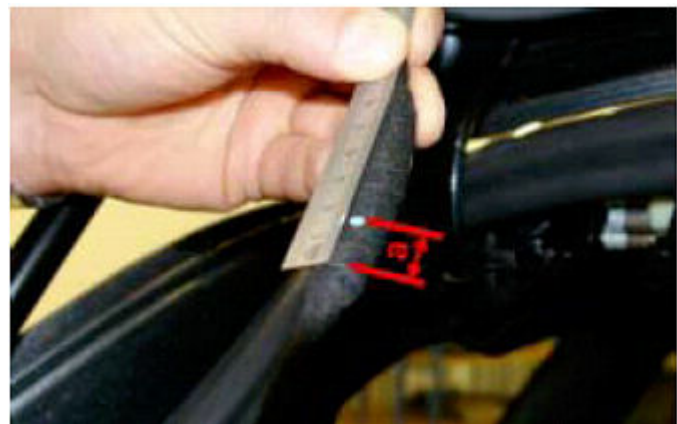
Figure 11. Mark 15 mm from the end of the reinforcing hose.

- Measure a distance of 15 mm (Figure 11, A) from the end of the reinforcing hose, and mark this point with a suitable pen.

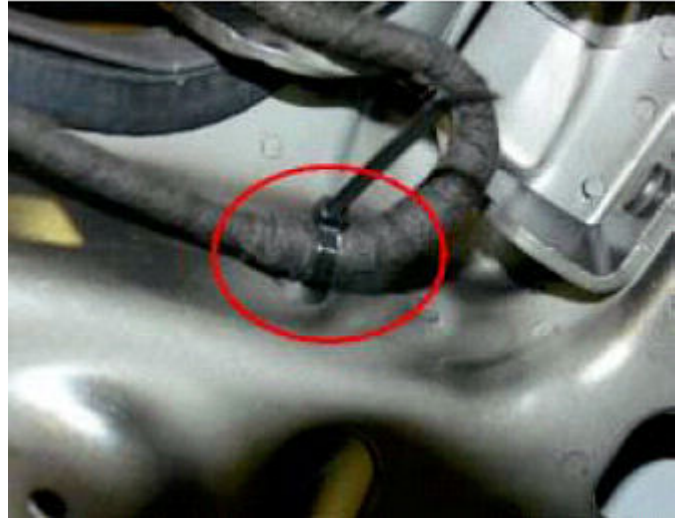
Figure 12. Secure the hose with a cable tie at this spot.

- Secure the hose with a cable tie at the point marked (Figure 12). Cut off excess length from cable tie.

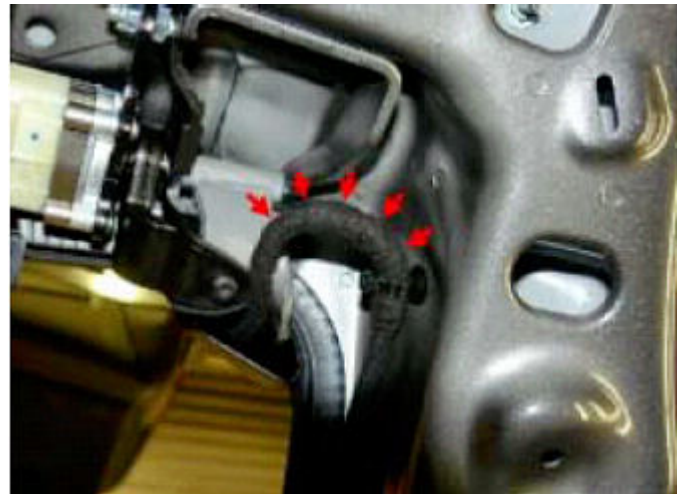
Figure 13. Ensure the hose has sufficient clearance and does not chafe when the tailgate is open.

- Install hinge cover.
- Check that the hose has sufficient clearance and does not chafe with the tailgate open.

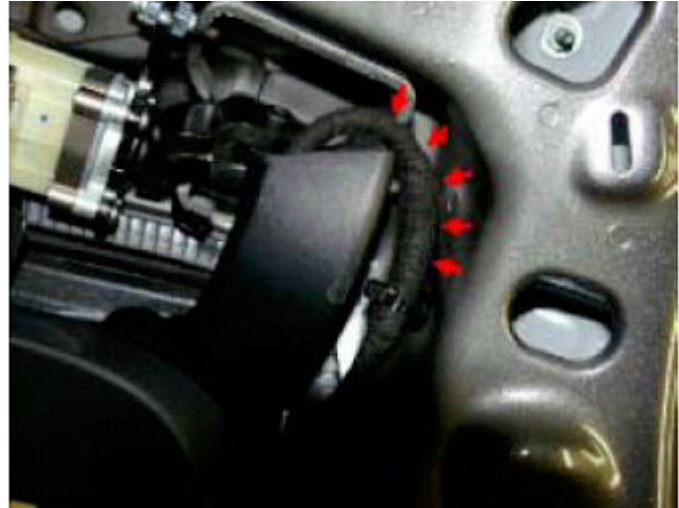
Figure 14. Ensure the hose has sufficient clearance and does not chafe when the tailgate is closed.

- Check that the hose has sufficient clearance and does not chafe with the tailgate closed.
- Check function of rear window washer.
- Top up washer fluid. Install trim components in reverse sequence to removal.
