Technical Bulletin

- Headlight range control warning is ON in driver information display. After cycling the ignition, warning symbol is OFF again.
- A sporadic DTC (01771 – Control module for vertical headlight aim control system –J431– implausible signal) is set in the Headlight Range Control Module.

94 06 02 Jun. 7, 2006, 2011041, Supersedes Technical Bulletin Group 94 number 06-01 dated May 24, 2006 due to updated table information.

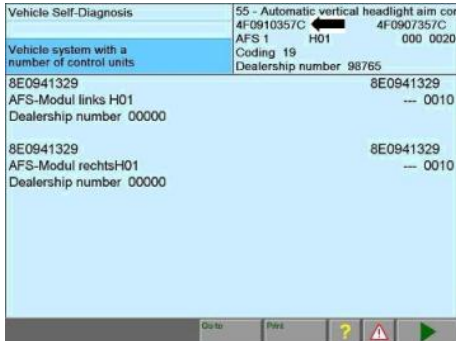
Similar screen appears.

- Check suffix following software part number (arrow).
- If software level suffix is already “E”, **DO NOT** continue with this bulletin. Update – Programming is not necessary. Further diagnosis is required for condition.
- If the hardware part number is 4F0 907 357 or 4F0 907 357A the module cannot be flashed and must be replaced. **DO NOT** continue with this bulletin.
- If software level suffix is “C”, perform Update – Programming procedure as follows:
