# Technical Service Bulletin

## Engine intermittently or consistently does not start using advance key start button, starts w/ key & ignition switch

96 07 01 Feb. 8, 2007, 2010941/4. Supersedes Technical Service Bulletin Group 96 number 06-03 dated Oct. 31, 2006 due to allowance of diagnostic time for warranty claims.

Model(s)	Year	VIN Range	Vehicle-Specific Equipment
A6	2005	All	Not Applicable
A6	2006	000001 – 079103

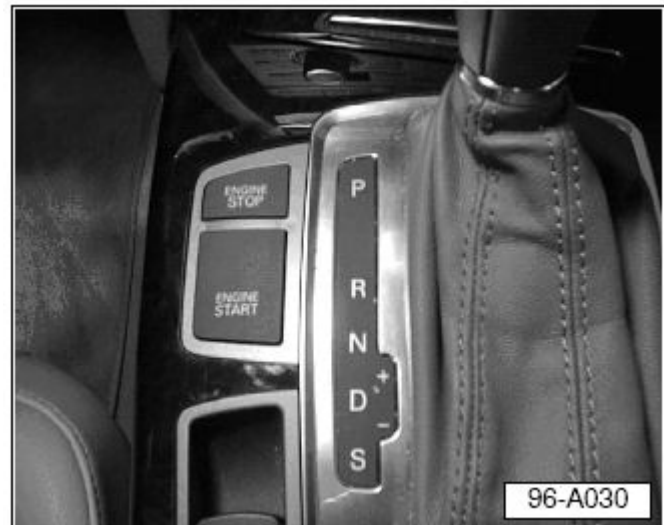
Customer states that engine does not start or intermittently does not start when Advance Key engine start button is depressed. Engine will start using ignition key and ignition switch.

*Figure 1. The Advance Key engine start button.*

- A – Mechanical issue with the engine start button.
- B – Electrical issue with the engine stop button.

In some cases, second detent, starter activation, cannot be achieved due to mechanical tolerances within the switch.

a. If engine start button is found to be non-functional, replace Advance Key engine start / engine stop switch. Refer to *Repair Manual* >> *Group 96 - Lights, Switches* >> *Interior, Anti- Theft* for appropriate repair procedure.
