HYUNDAI Technical Service Bulletin

Group	BODY
Number	09-BD-008
Date	JULY, 2009
Model	GENESIS COUPE (BK)

Subject	QUARTER INNER PANEL NOISE REPAIR
---------	---

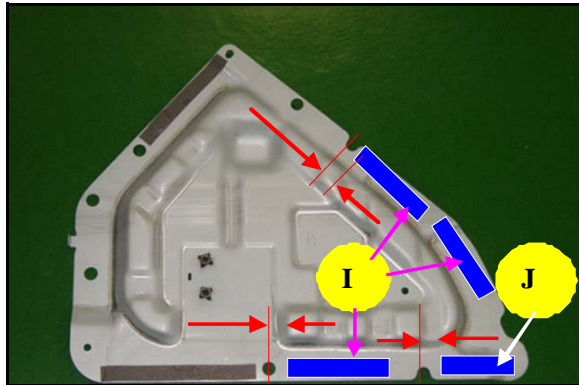
Some Genesis Coupe vehicles may exhibit a vibration noise originating from the rear quarter inner panel.

8. Apply the 120mm anti-squeak pads (I) supplied in the kit and the 80mm anti-squeak pad (J) as shown.
