HYUNDAI Technical Service Bulletin

Group	BODY
Number	09-BD-009
Date	AUGUST, 2009
Model	2010 GENESIS COUPE (BK)

Subject
FRONT BUMPER COVER GAP ADJUSTMENT

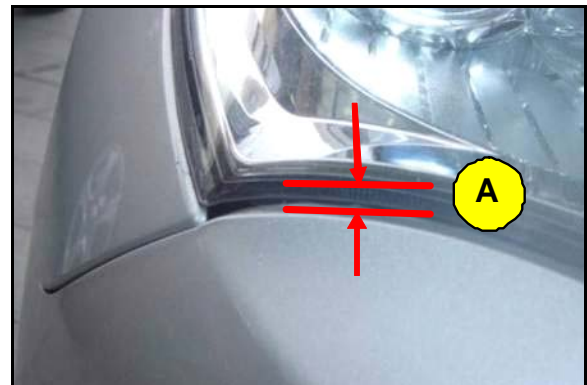
1. Check the gap (A) between the lower edge of the head lamp and the upper edge of the front bumper cover.

NOTE: Specified gap: 3.0±0.5mm

2. If the gap exceeds the specification, adjust the gap by following the below procedures.
