# Technical Service Bulletin

## RVU - Thumping, knocking or popping noise in fuel tank area (IH)

20 07 05 June 15, 2007 2015111/2. Supersedes Technical Service Bulletin Group 20 number 07-04 dated June 7, 2007 to correct Saga data.

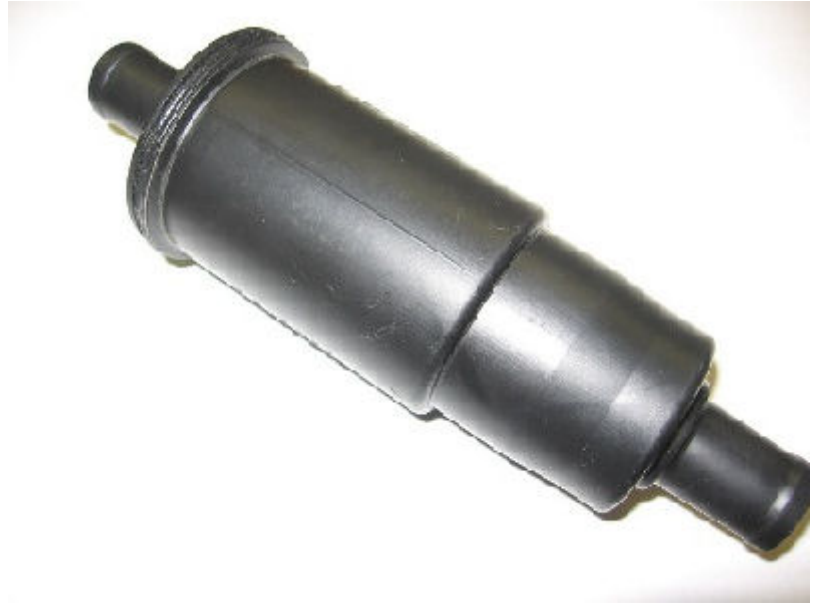
Filtration element was too fine in the original in-line filter (part number **4F0 201 801 A**) for the leak detection pump. In some cases, the filter becomes obstructed by particulate buildup that impedes tank pressure normalization. This condition leads to nonlinear corrections in tank pressure, thus causing a thumping noise.

*Figure 1. In-line LDP filter 4F0 201 801 A.*

Vehicles produced after the specified VIN break are equipped with an improved filter (part number **4F0 201 801 B**).

Replace in-line LDP filter with improved part **4F0 201 801 B** and verify elimination of the noise.

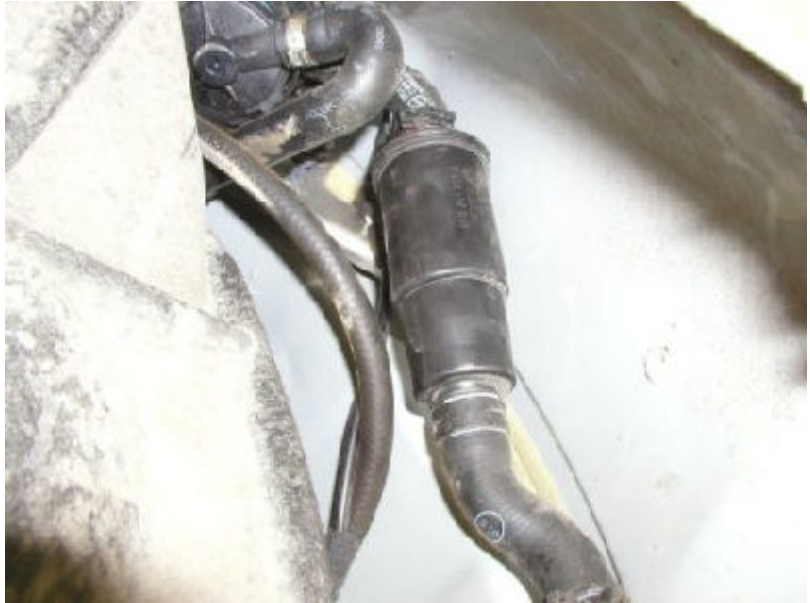
*Figure 2. Filter location in left-rear wheel well on an affected A6 vehicle.*

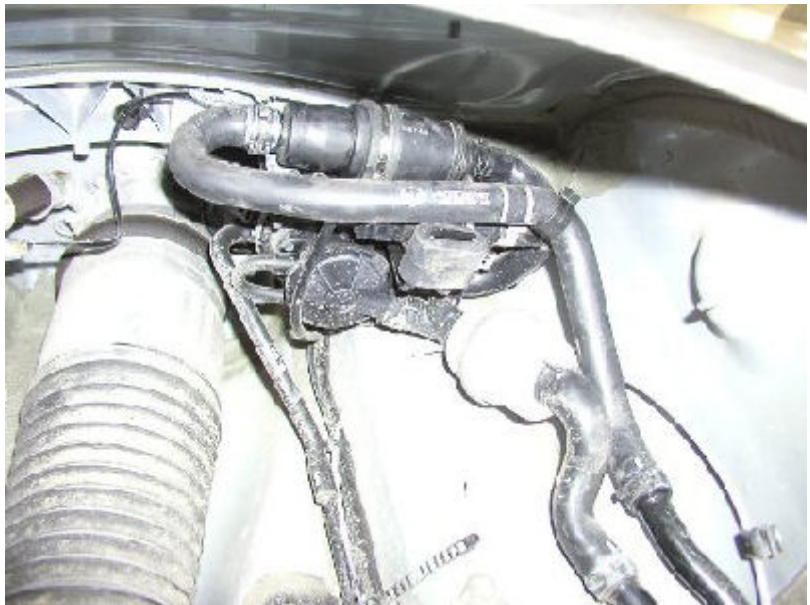
*Figure 3. Filter location in left-rear wheel well on an affected A8 vehicle.*
