# HYUNDAI Technical Service Bulletin

Group	CAMPAIGN
Number	09-01-009
Date	MARCH, 2009
Model	2010 GENESIS COUPE (BK)

Subject  
**HIGH MOUNTED STOP LAMP MOUNTING SCREWS REPLACEMENT (CAMPAIGN T84)**

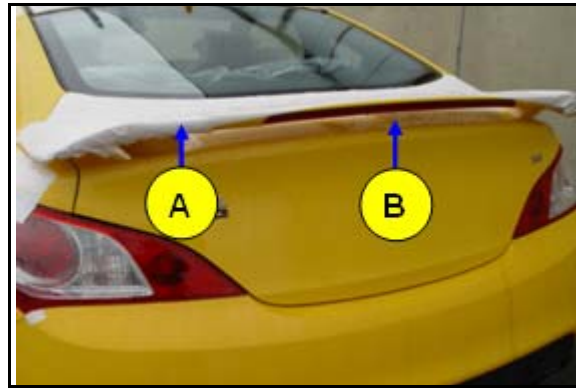
1. Locate the high mounted stop lamp on the rear spoiler (A).
