Technical Service Bulletin

MMI Surround setting lost

91 07 08 2013108/2, Feb. 20, 2007. Supersedes Technical Service Bulletin Group 91 number 06-25 dated Nov. 1, 2006 due to release of new update CD.

Model(s)	Year	VIN Range	Vehicle-Specific Equipment
A6	2006	All	BOSE Sound System
A8	2006	All

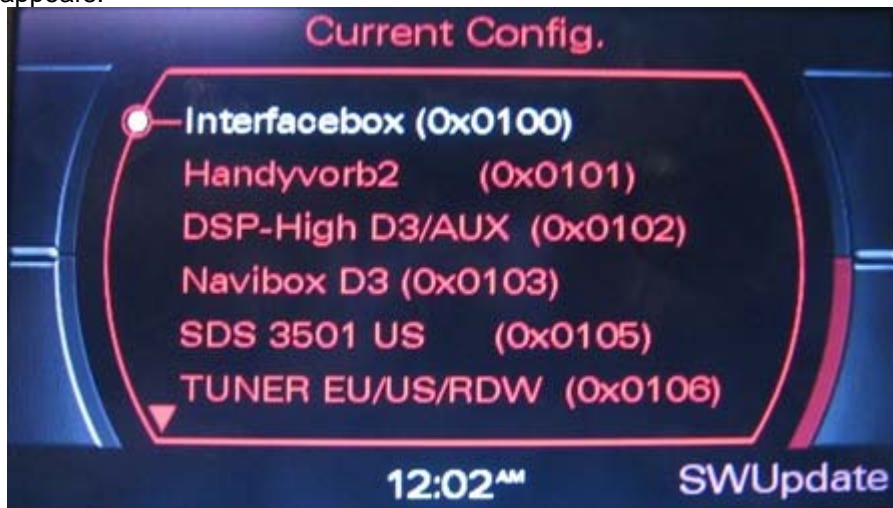
4. Press and hold the MMI Control Head - buttons: **Setup** and **Return** simultaneously until the following screen appears:

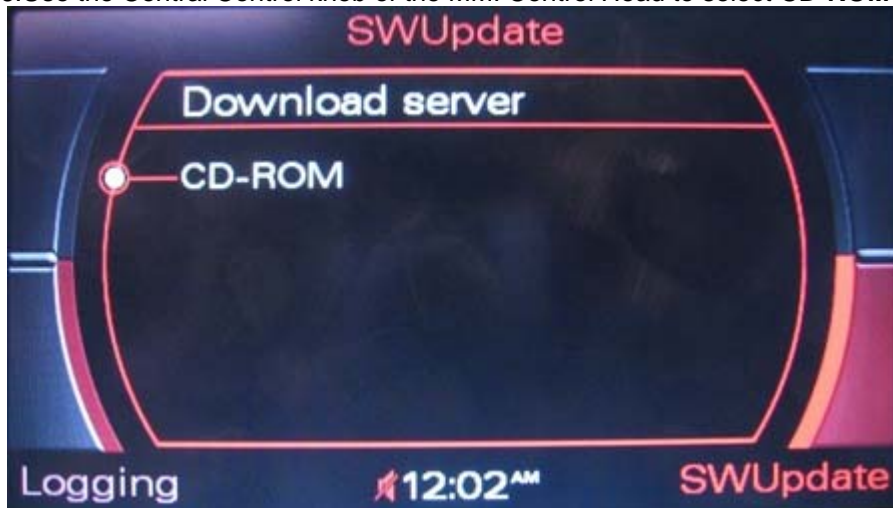
6. Use the Central Control knob of the MMI Control Head to select **CD-ROM** and then **Standard**.

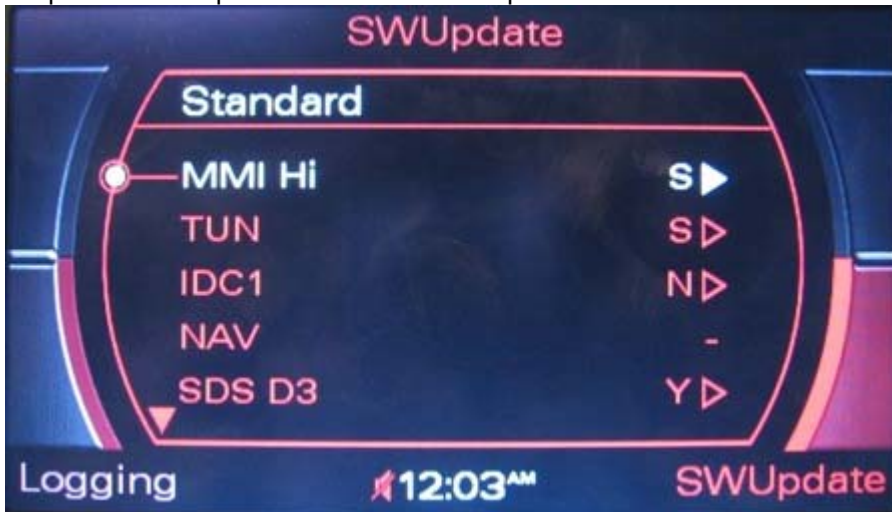
7. The screen below, which may take a few seconds to appear, shows the current software status of the MMI component in comparison to the inserted Update CD.

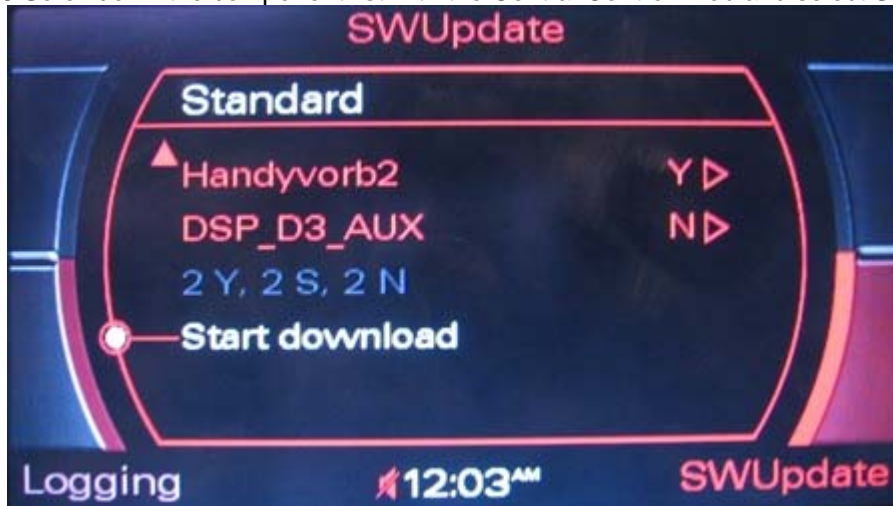
8. Scroll down the component list with the Central Control knob and select **Start download**.

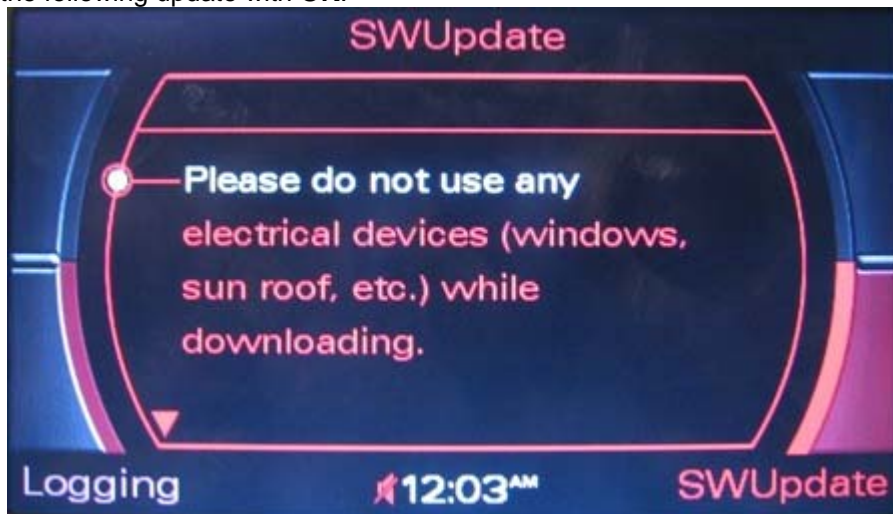
9. Note and obey the displayed message to avoid component breakdowns, and scroll down the screen to accept the following update with **OK**.

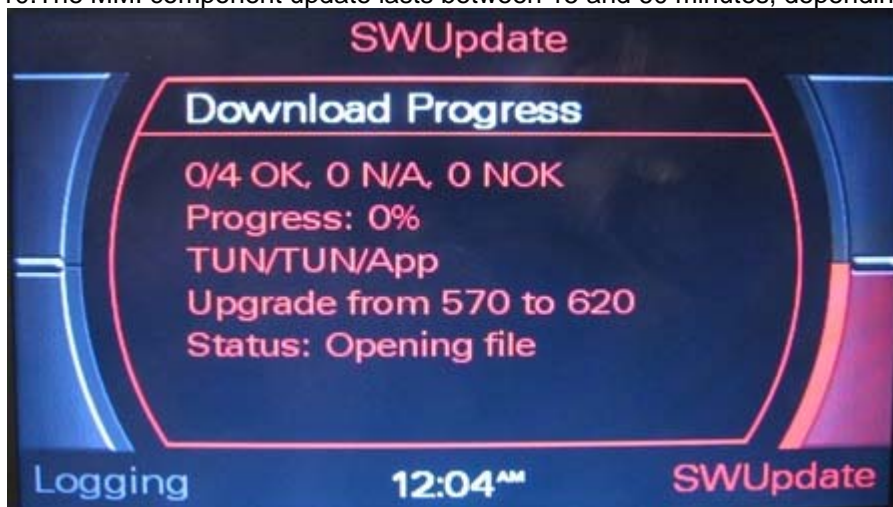
10. The MMI component update lasts between 15 and 60 minutes, depending on the installed components.

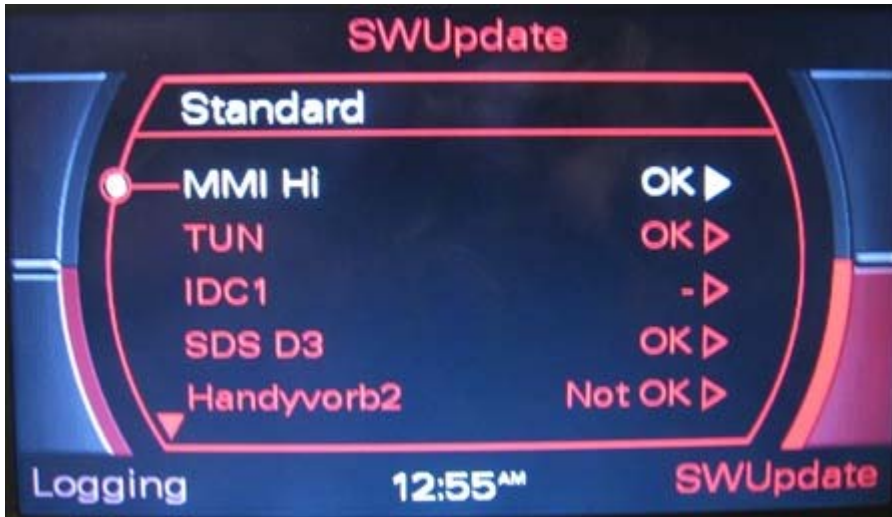
The displayed status **Not OK** and - is update-related and not a fault. Please ignore and proceed.

If you scroll down the component list you may encounter, that not all necessary component updates were performed in the first step (e.g. 1 NOK). In this case, select **Try again** to perform the missing component update.

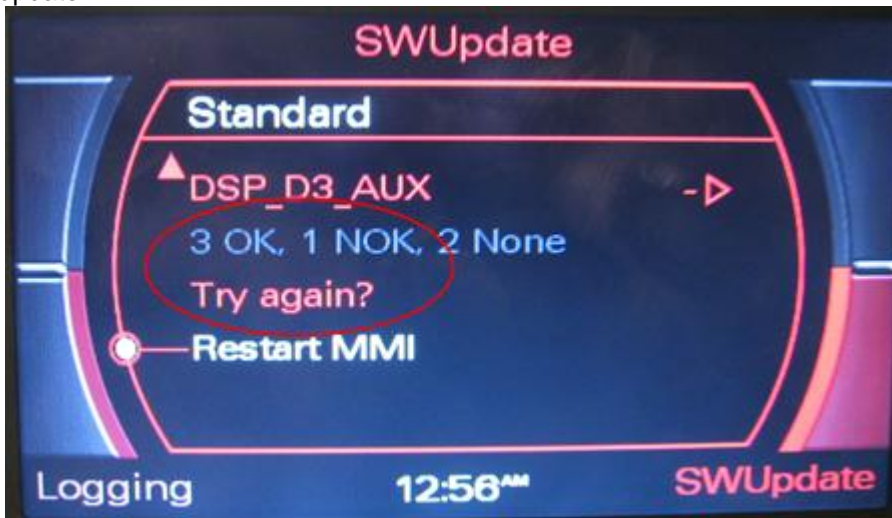
If all necessary components are updated (0 NOK) select **Restart MMI** to reset the MMI system.
