Technical Service Bulletin

Only one satellite radio station is displayed and playing with activated Tuner

91 07 11 2014223/1, Feb. 20, 2007

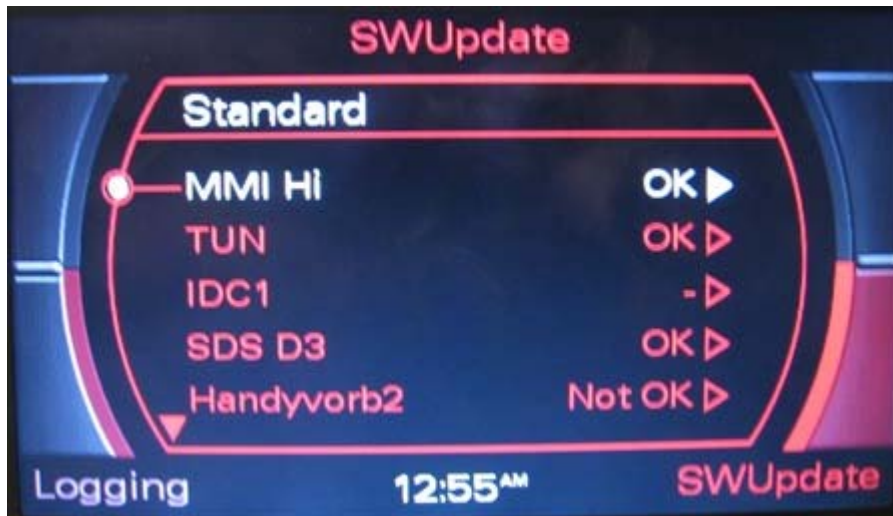
Tip: The displayed status **Not OK** and - is update-related and not a fault. Please ignore and proceed.

13. After initialization of the updated components, the following screen (or a similar one) appears.
