# Technical Service Bulletin

## MMI Surround setting lost

91 07 22 May 21, 2007 2015136/1

Model(s)	Year	VIN Range	Vehicle-Specific Equipment
A6	2005	All	BOSE System and Zug 317 installed
A8	2004 – 2005	All

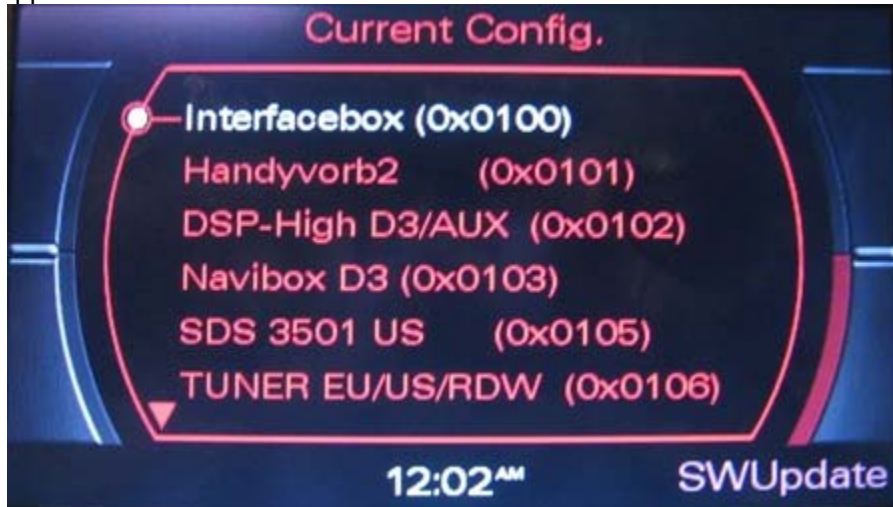
5. Press and hold the MMI Control Head buttons **Setup** and **Return** simultaneously until the following screen appears:

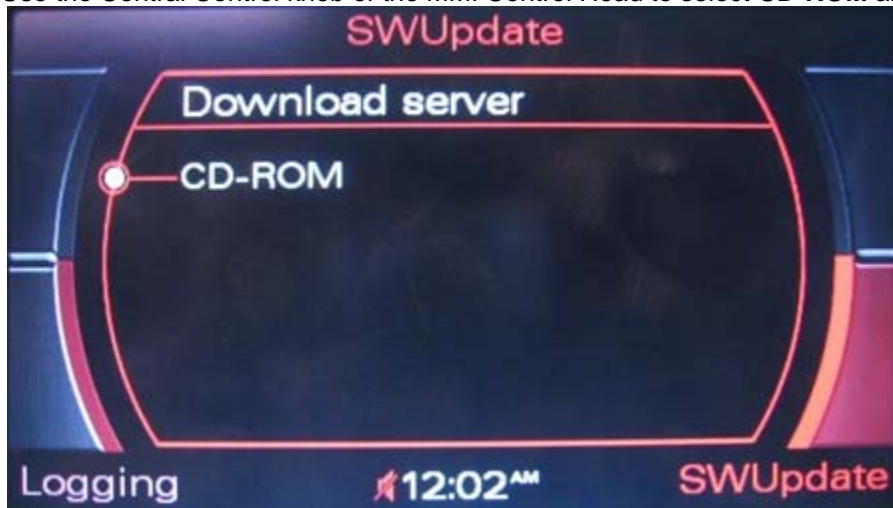
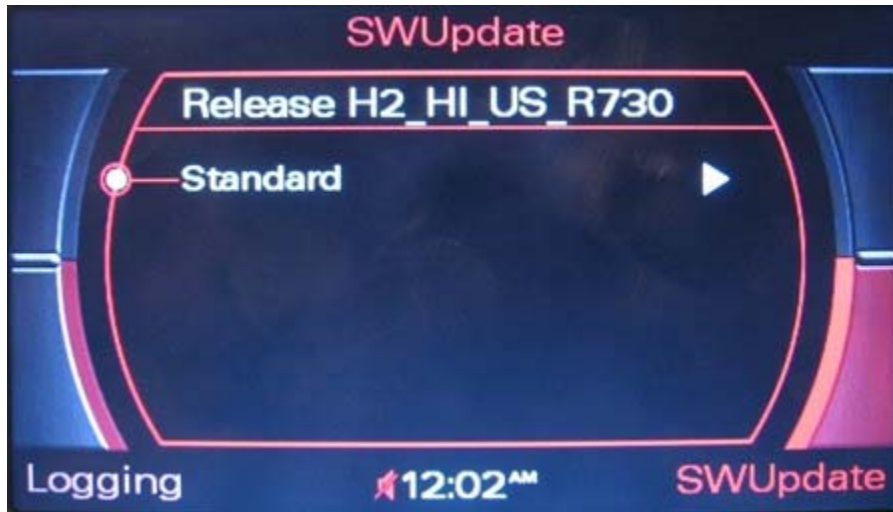
6. Press the lower right soft key of the MMI Control Head to enter the **SWUpdate** menu.
7. Use the Central Control knob of the MMI Control Head to select **CD-ROM** and then **Standard**.

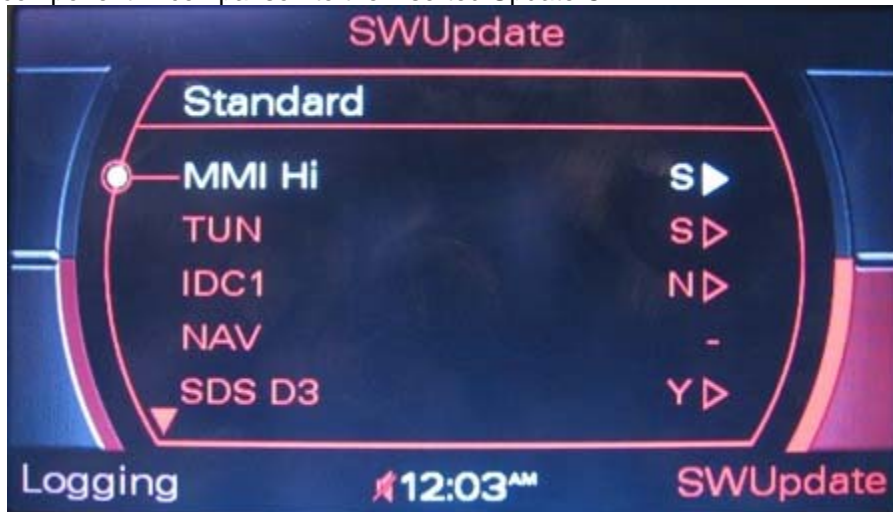
8. The screen below, which may take a few seconds to appear, shows the current software status of the MMI component in comparison to the inserted Update CD.

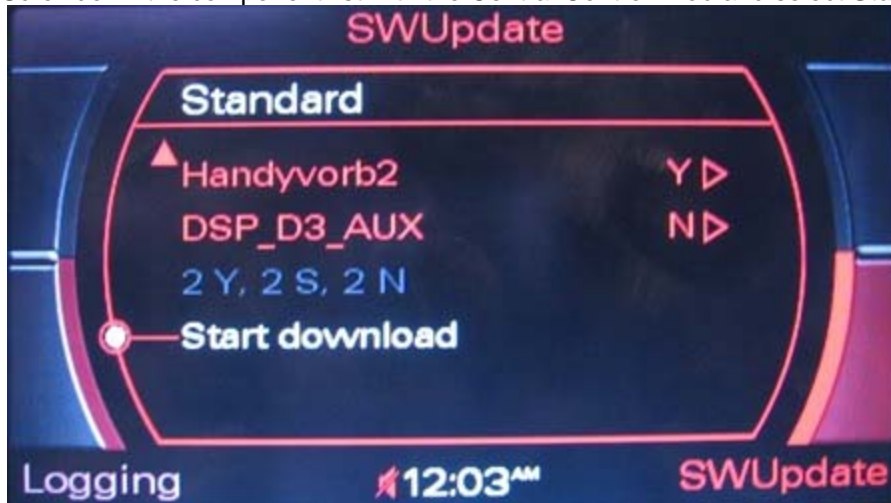
9. Scroll down the component list with the Central Control knob and select **Start download**.

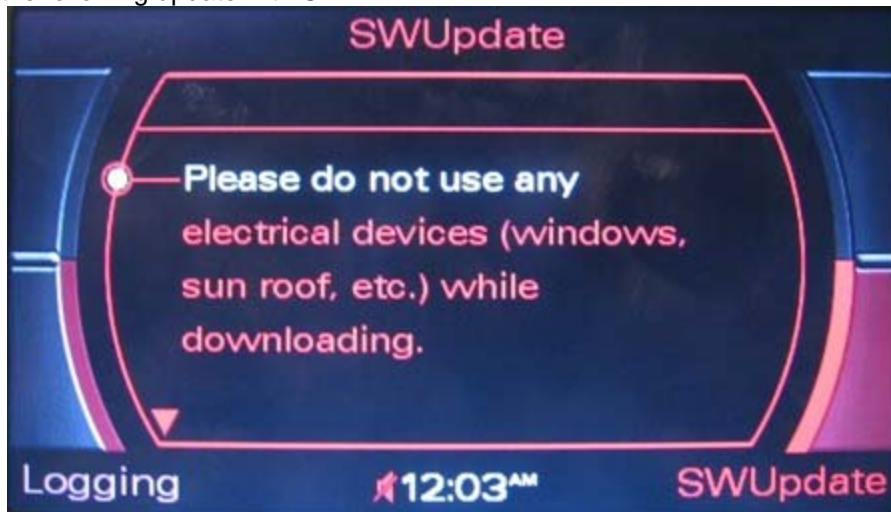
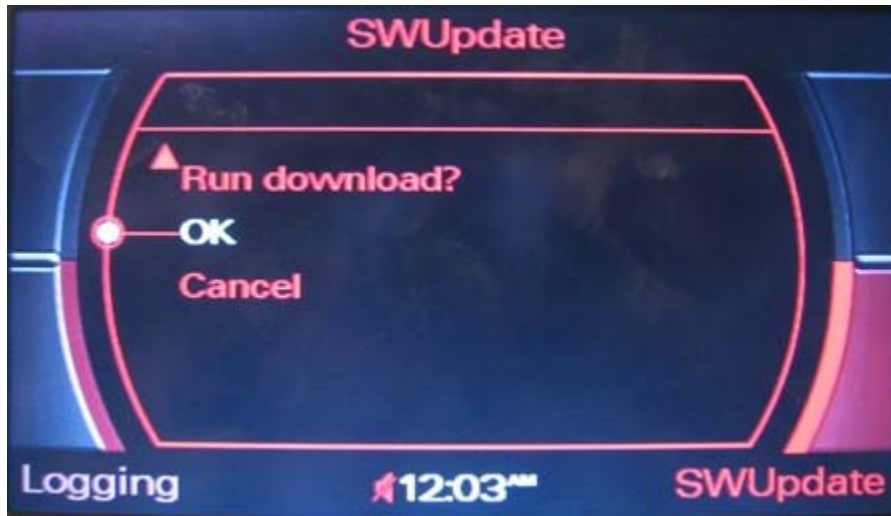
10. Note and obey the displayed message to avoid component breakdowns, and scroll down the screen to accept the following update with **OK**.

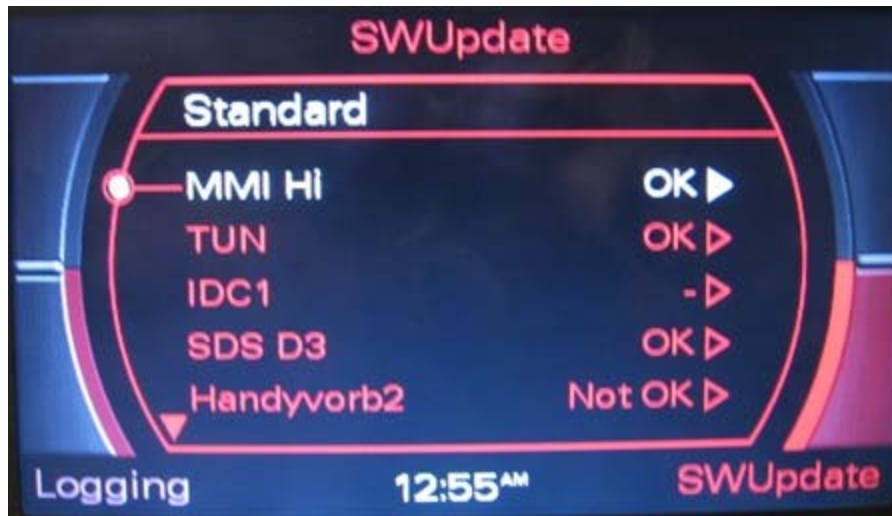
12. After initialization of the updated components, the following screen (or a similar one) appears.

The displayed status **Not OK** and - is update-related and not a fault. Please ignore and proceed.

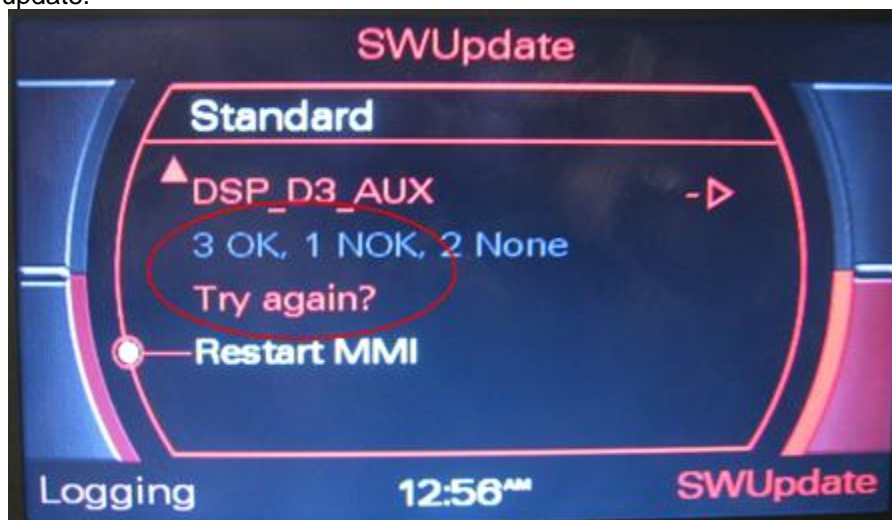
If you scroll down the component list, you may discover that not all necessary component updates were performed in the first step (e.g. **1 NOK**). In this case, select **Try again** to perform the missing component update.

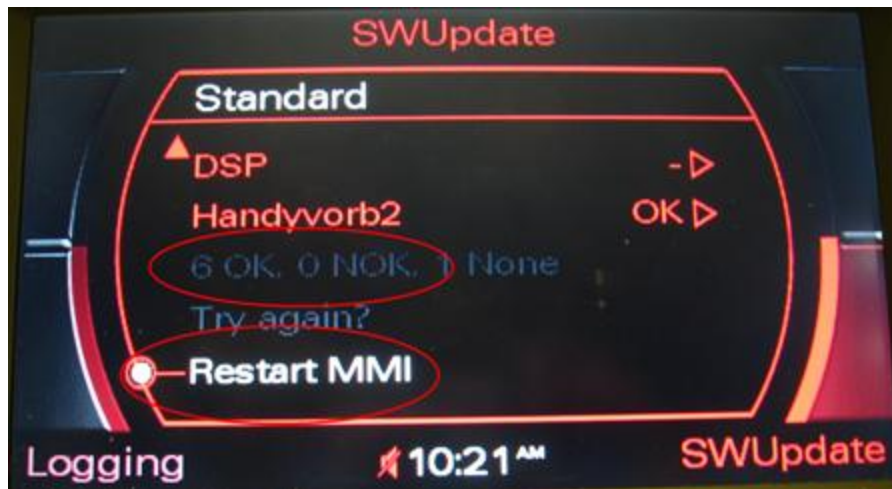
If all necessary components are updated (**0 NOK**), select **Restart MMI** to reset the MMI system.
