Technical Service Bulletin

RVU - A6 Avant rear washer hose (IT)

92 07 01 March 2, 2007, 2013391/3. Supersedes Technical Service Bulletin Group 92 number 06-03 dated Nov. 27, 2006 due to addition of Saga warranty information.

Model(s)	Year	VIN Range	Vehicle-Specific Equipment
A6 Avant	2006	All	Not Applicable

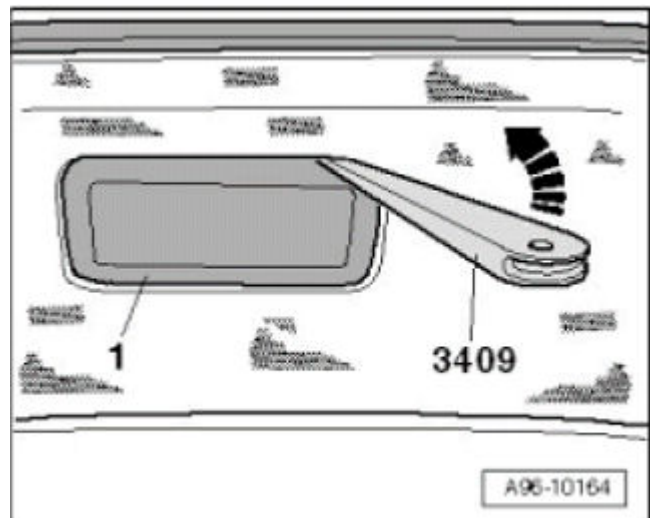
Figure 2. Use removal wedge 3409 to pry out the luggage compartment light (1).

- Carefully pry out luggage compartment light (Figure 2, 1) from opening in headliner using removal wedge 3409 (Figure 2, 3409).
- Unplug electrical connector.

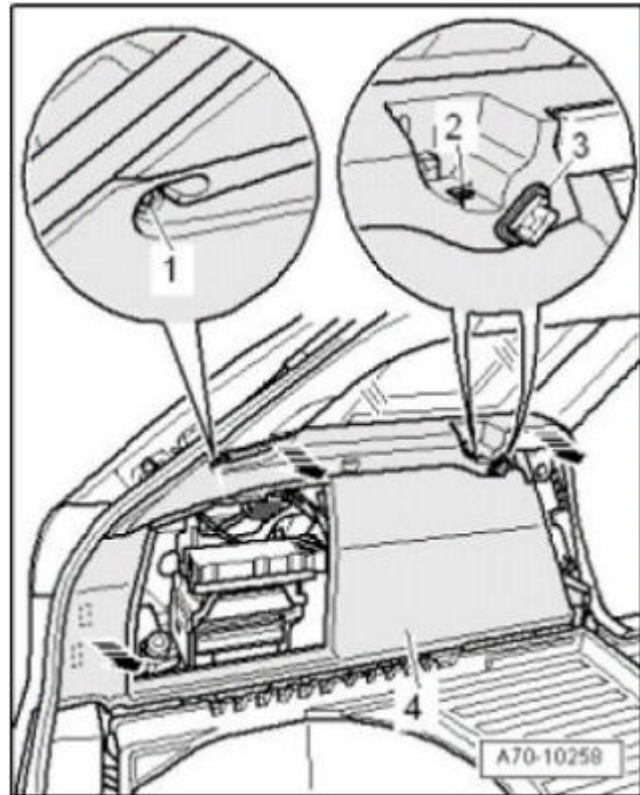
Figure 3. Remove the luggage compartment side trim.

- Remove cover from luggage compartment side trim.
- Remove bolt (Figure 3, 1).
- Pry spring clips out of body panel.

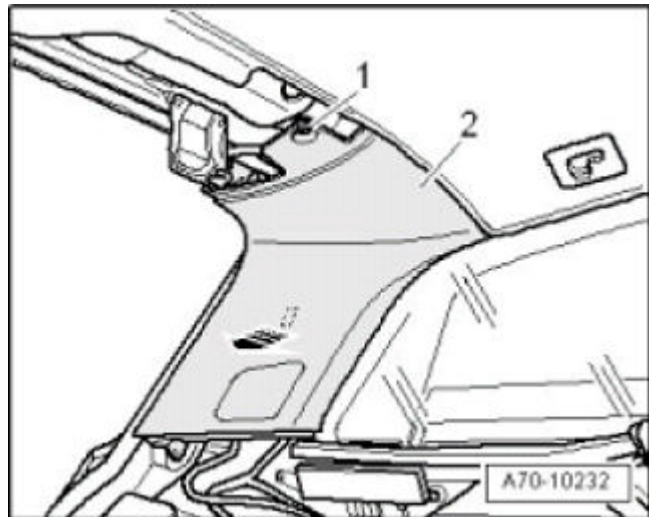
Figure 4. Remove bolt (1) and pull D-pillar trim (2) away from body panel.

- Remove bolt (Figure 4, 1).
- Pull D-pillar trim (Figure 4, 2) away from body panel.

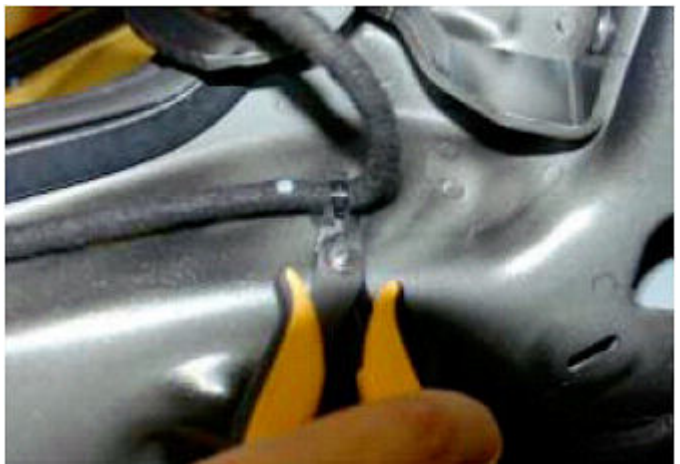
Figure 7. Open cable tie.

- Open cable tie.

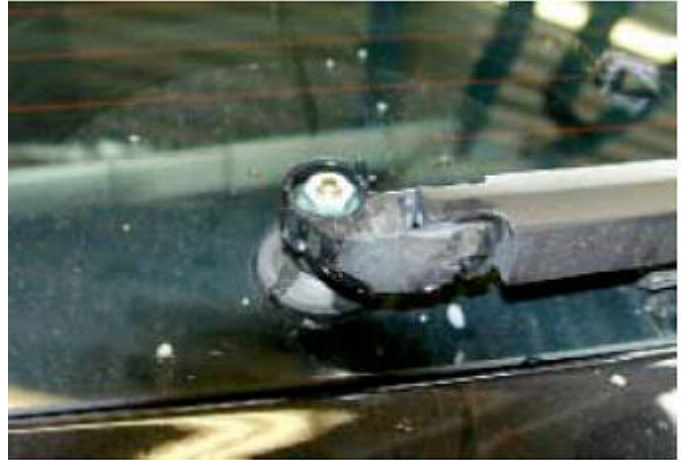
Figure 8. Pull cap off rear window washer nozzle.

- Pull cap off rear window washer nozzle.

- Operate the rear window washer for approximately five seconds while a second mechanic holds a finger over the washer nozzle to keep it closed.
- Then check the hose for leaks in the vicinity of the cable tie (visual inspection).
