Technical Service Bulletin

BOSE Sound System without function, no sound

91 07 05 2013107/4, Feb. 20, 2007. Supersedes Technical Service Bulletin Group 91 number 06-36 dated Dec. 13, 2006 due to release of new update CD.

Model(s)	Year	VIN Range	Vehicle-Specific Equipment
A6	2006	All	BOSE Sound System (J525 SW Version 0140)

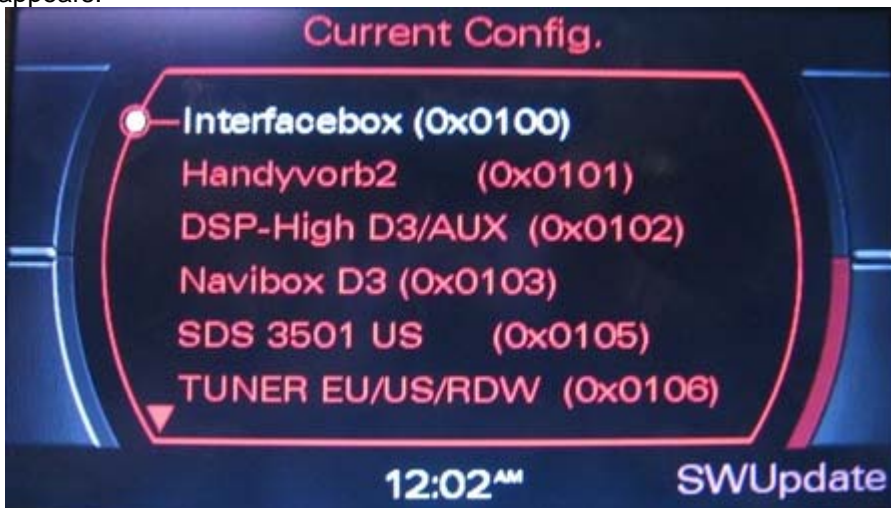
4. Press and hold the MMI Control Head - buttons: **Setup** and **Return** simultaneously until the following screen appears:

5. Press the lower right soft key of the MMI Control Head to enter the **SWUpdate** menu.

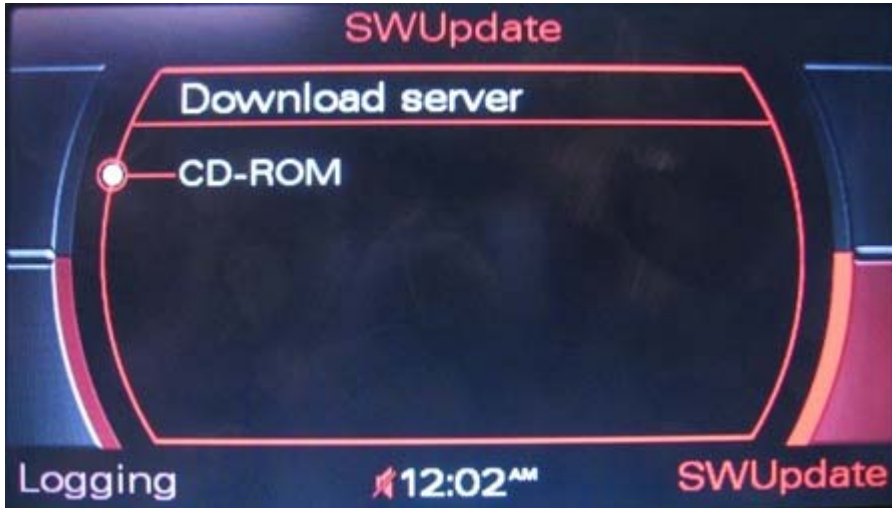
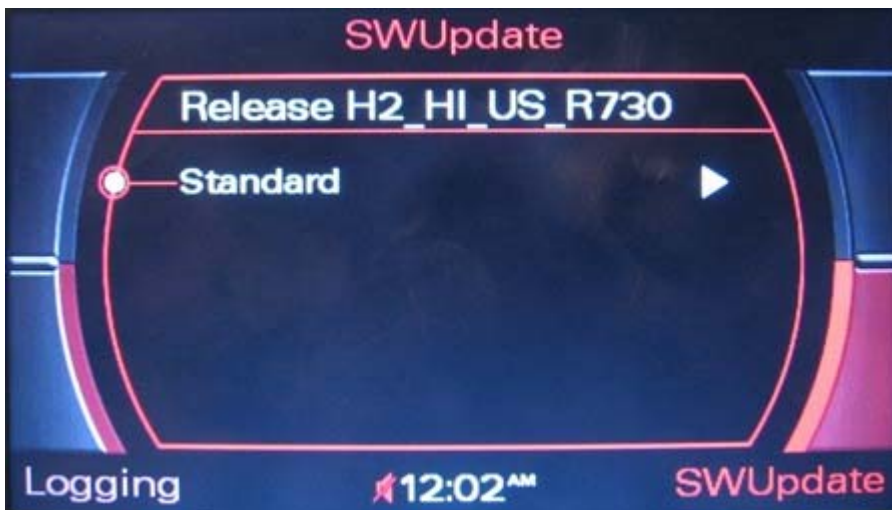
6. Use the Central Control knob of the MMI Control Head to select **CD-ROM** and then **Standard**.

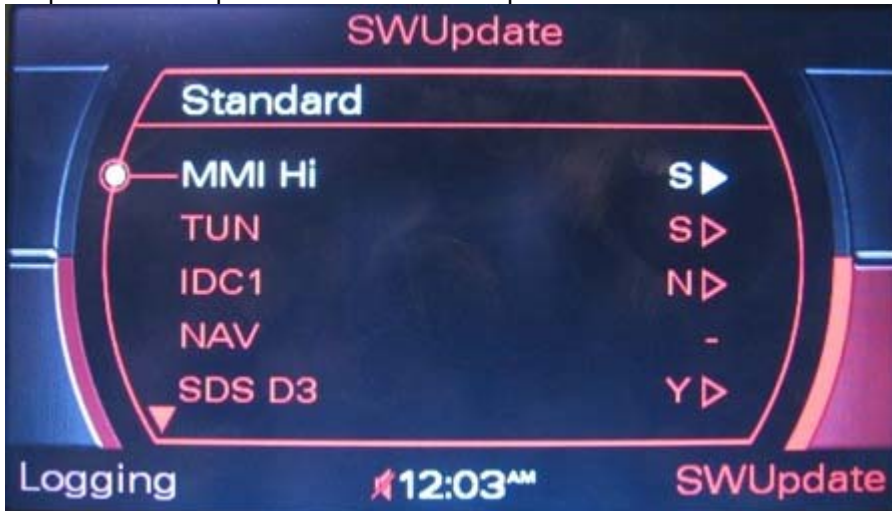
7. The screen below, which may take a few seconds to appear, shows the current software status of the MMI component in comparison to the inserted Update CD.

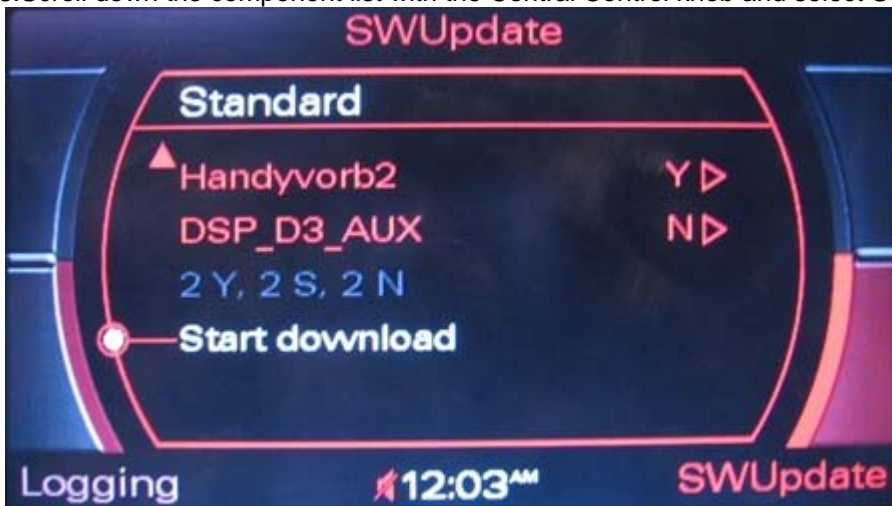
8. Scroll down the component list with the Central Control knob and select **Start download**.

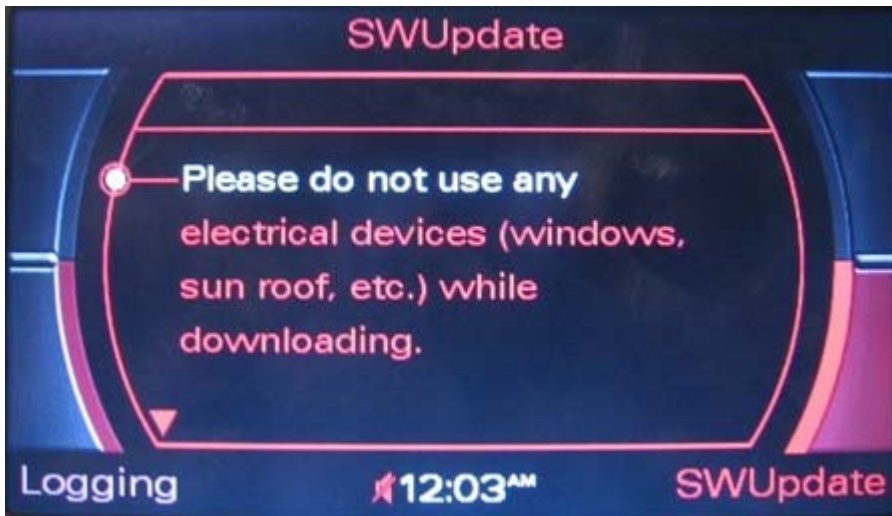
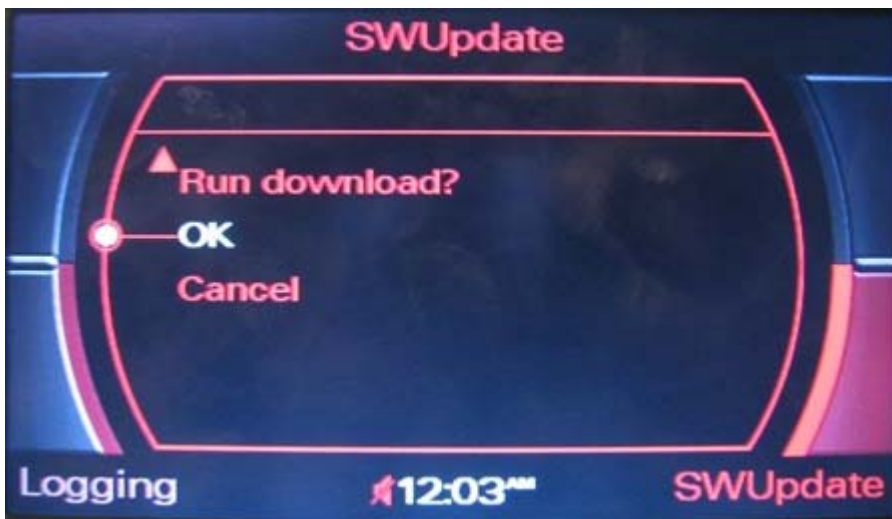
9. Note and obey the displayed message to avoid component breakdowns, and scroll down the screen to accept the following update with **OK**.

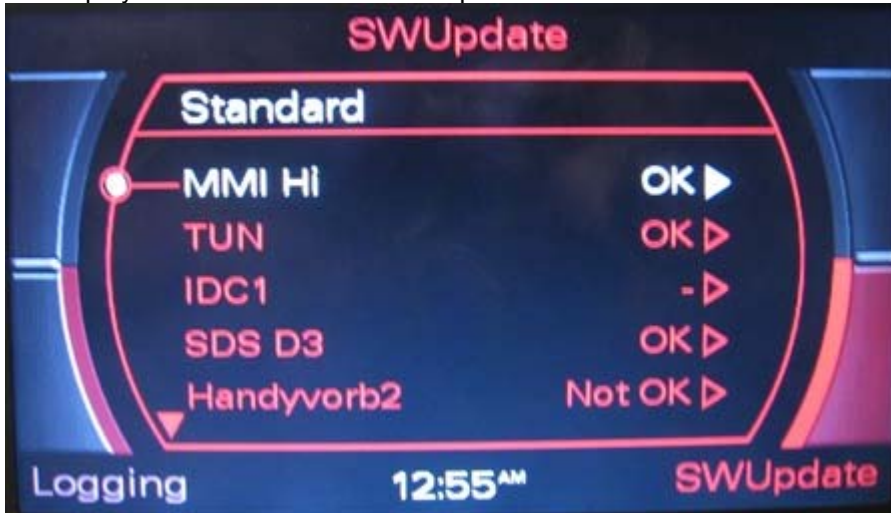
11. After initialization of the updated components, the following screen (or a similar one) appears.

The displayed status **Not OK** and - is update-related and not a fault. Please ignore and proceed.

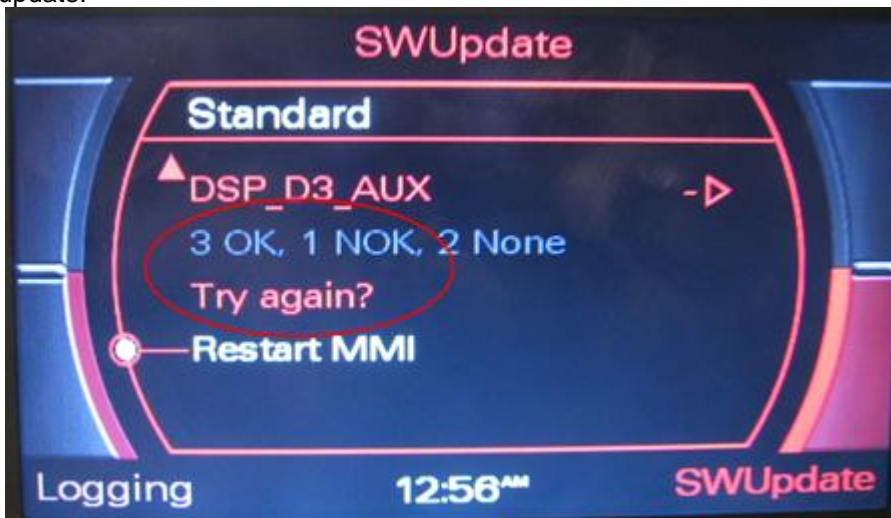
If you scroll down the component list you may encounter, that not all necessary component updates were performed in the first step (e.g. 1 NOK). In this case, select **Try again** to perform the missing component update.

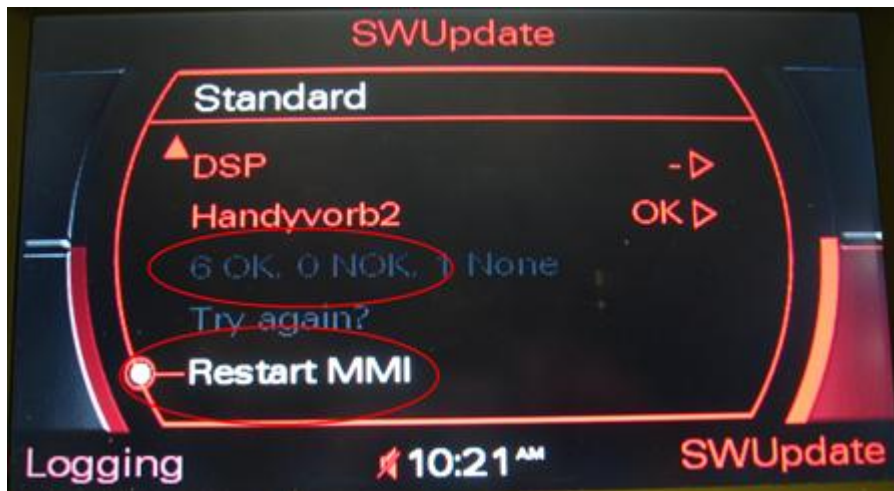
If all necessary components are updated (0 NOK) select **Restart MMI** to reset the MMI system.
