Technical Service Bulletin

Navigation vehicle symbol jumps in map overview

91 07 09 2014126/1, Feb. 20, 2007

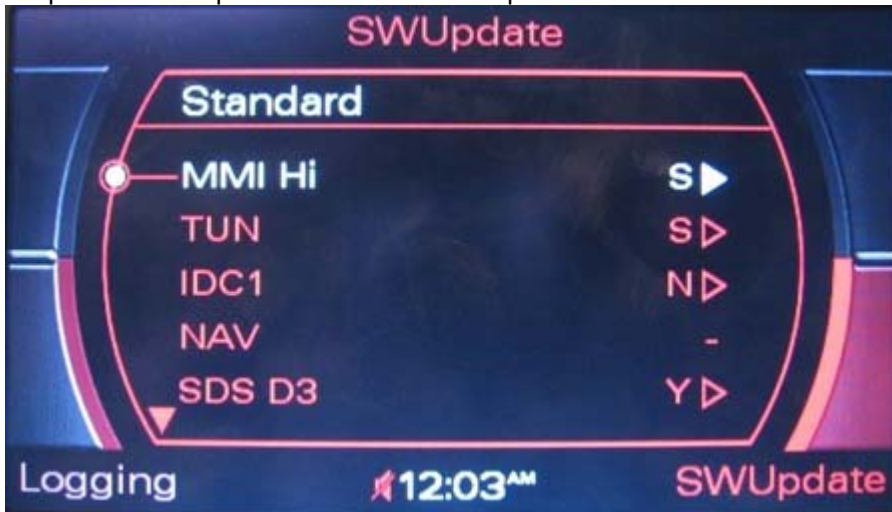
7. The screen below, which may take a few seconds to appear, shows the current software status of the MMI component in comparison to the inserted Update CD.

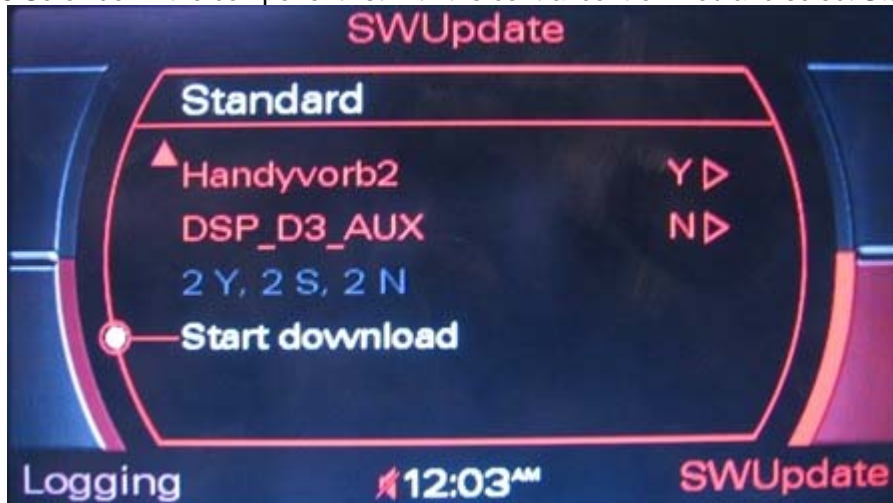
8. Scroll down the component list with the central control knob and select **Start download**.

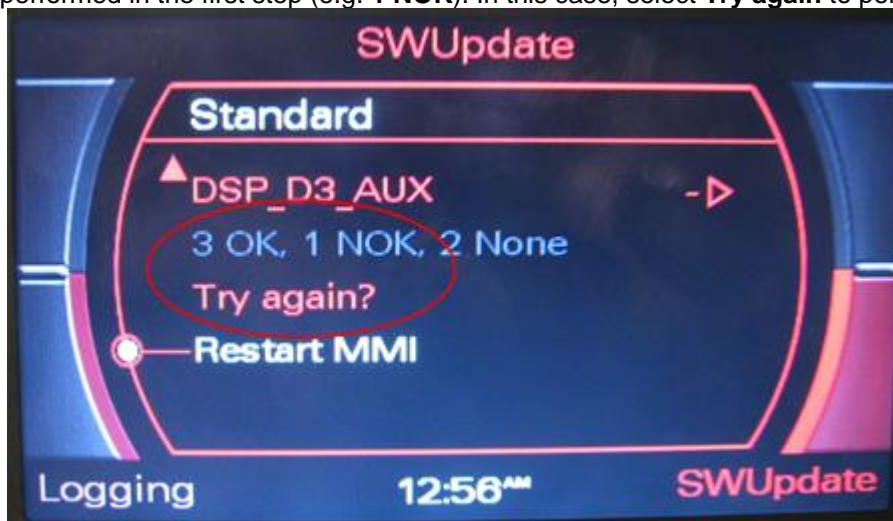
If you scroll down the component list, you may discover that not all necessary component updates were performed in the first step (e.g. **1 NOK**). In this case, select **Try again** to perform the missing component update.
