HYUNDAI Technical Service Bulletin

Group	BODY (INTERIOR/EXTERIOR)
Number	09-BD-007
Date	JULY, 2009
Model	2010 GENESIS COUPE(BK)

Subject
GENESIS COUPE (BK) DOOR BELT WEATHERSTRIP CHANGE

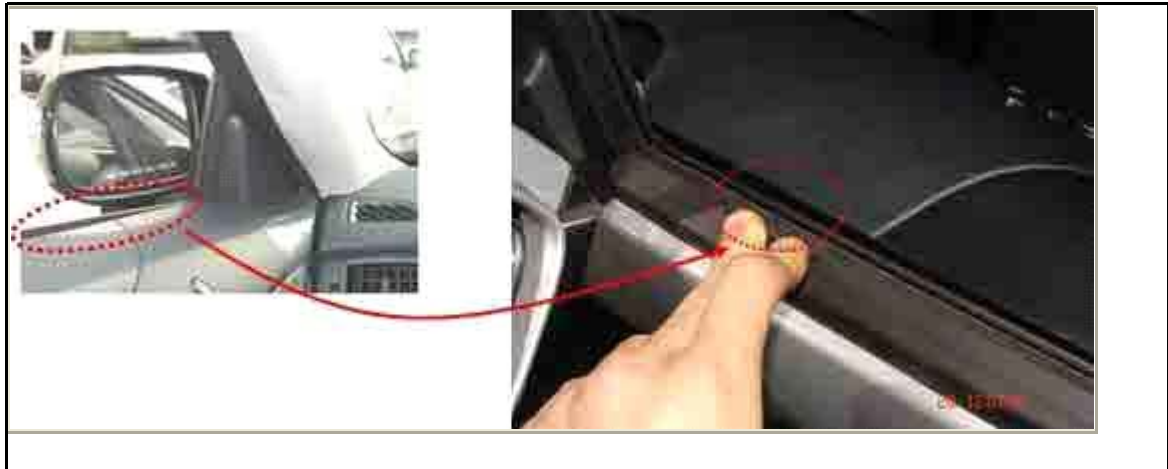
This bulletin provides information on changes in Genesis Coupe (BK) door belt weatherstrips as shown below.

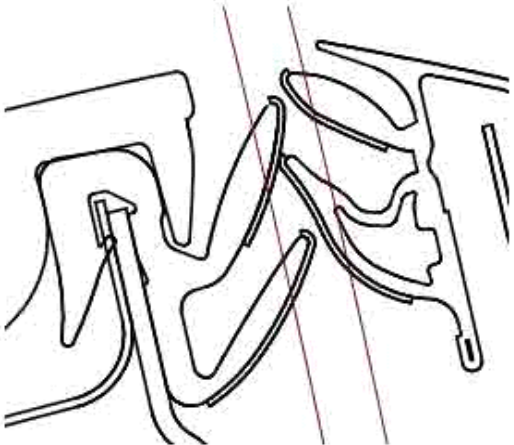
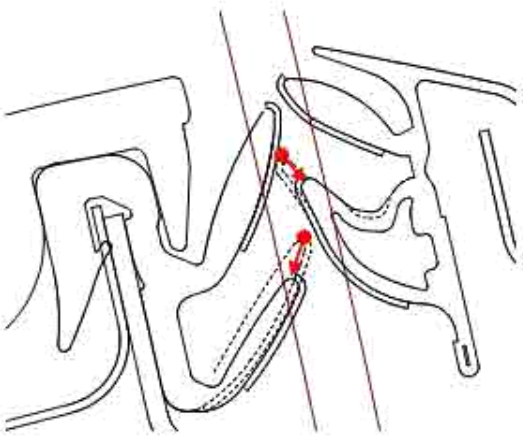
Previous		New

- Lower lip of inside door belt weatherstrip has been cut by 4 mm.
- Lower lip of outside door belt weatherstrip has been cut by 4.5 mm.

Door belt - Inside	82231 - 2M0009P (LH) 82241 - 2M0009P (RH)	Door belt - Inside	82231 - 2M0019P (LH) 82241 - 2M0019P (RH)
Door belt - Outside	82210 - 2M000 (LH) 82220 - 2M000 (RH)	Door belt - Outside	82210 - 2M001 (LH) 82220 - 2M001 (RH)

NOTE: The previous door belt weatherstrips are not available as service parts. When the replacement of a door belt weatherstrip is required, use a new type replacement part.
